**TECHNICAL STUDY**  
**FOR REHABILITATION**  
**ON PRAMBANAN TEMPLE COMPOUND**  
**AFTER EARTHQUAKE**

BY  
**TECHNICAL STUDY TEAM**  
**ARCHAEOLOGICAL OFFICE OF YOGYAKARTA**

**DEPARTMENT OF CULTURE AND TOURISM**  
**2007**

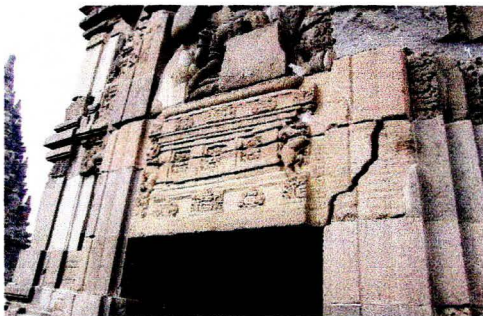
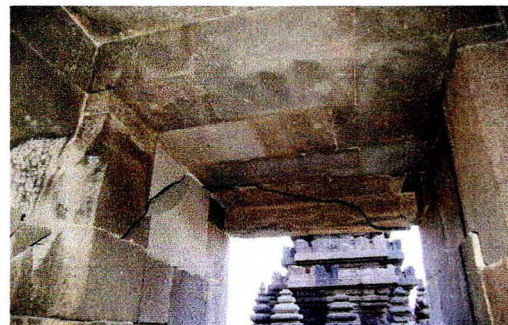
*Cracks on the outer wall and alley of west gate way of Siwa Temple.*

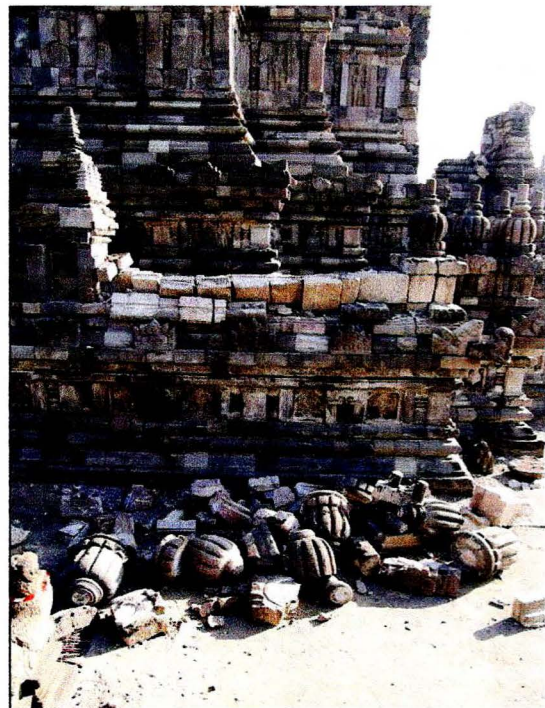
*Material damage on Brahma and Wisnu temple*

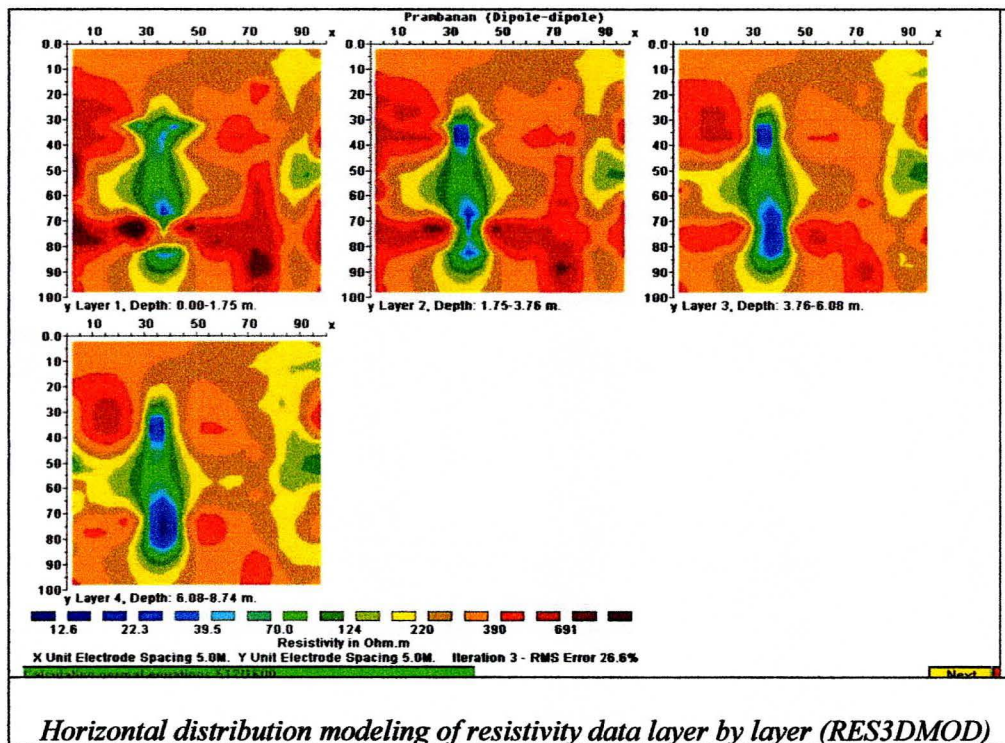
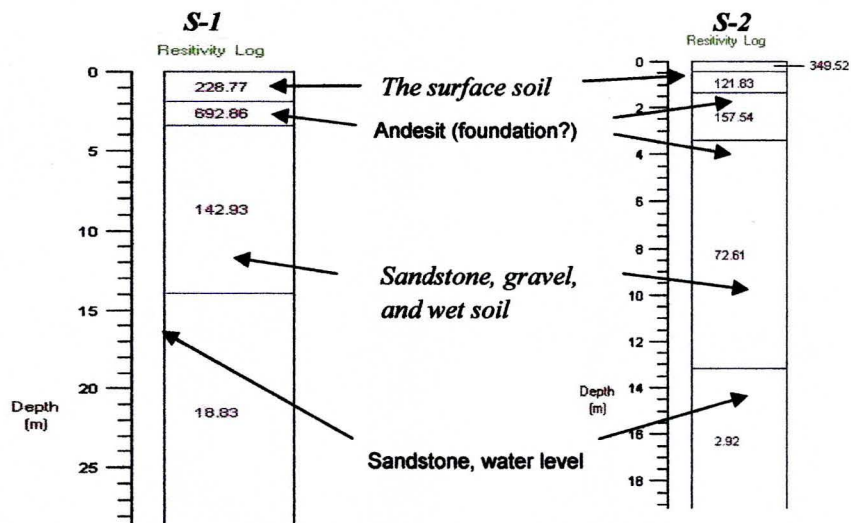
The vertical electrical sounding interpretation of point S1 and S2 are illustrated in Fig 3. S1 is located in east side of Siwa and S2 is located in west side of Nandi. Based on the model, thick of the surface soil is less than 2 m, and there is about 2 m thick of high resistivity layer (ohm-m) at Siwa floor. We interpret it as an andesitis rock or a foundation rock. However, in S2 the resistivity is not so high, and lower than this layer is low resistivity area, it may be a wet sandstone, wet soil, and gravel as a water level. According to Ijzerman in Jordaan, 1996 in a depth of 5.75 m under the floor, there was a container 41 cm long and wide and 53 cm deep. The top of lid, which is made of soft marlstone, is diamond-shape and coping of soft, light-yellow sandstone fits into the container. The foundation consists of three layers of stone, which together achieve a thickness of 1.15 m, on digging further, round river stones in sand were discovered and at 15.90 m, water.

*Vertical electrical sounding interpretation of points S1 and S2 by Progress 3.0.*

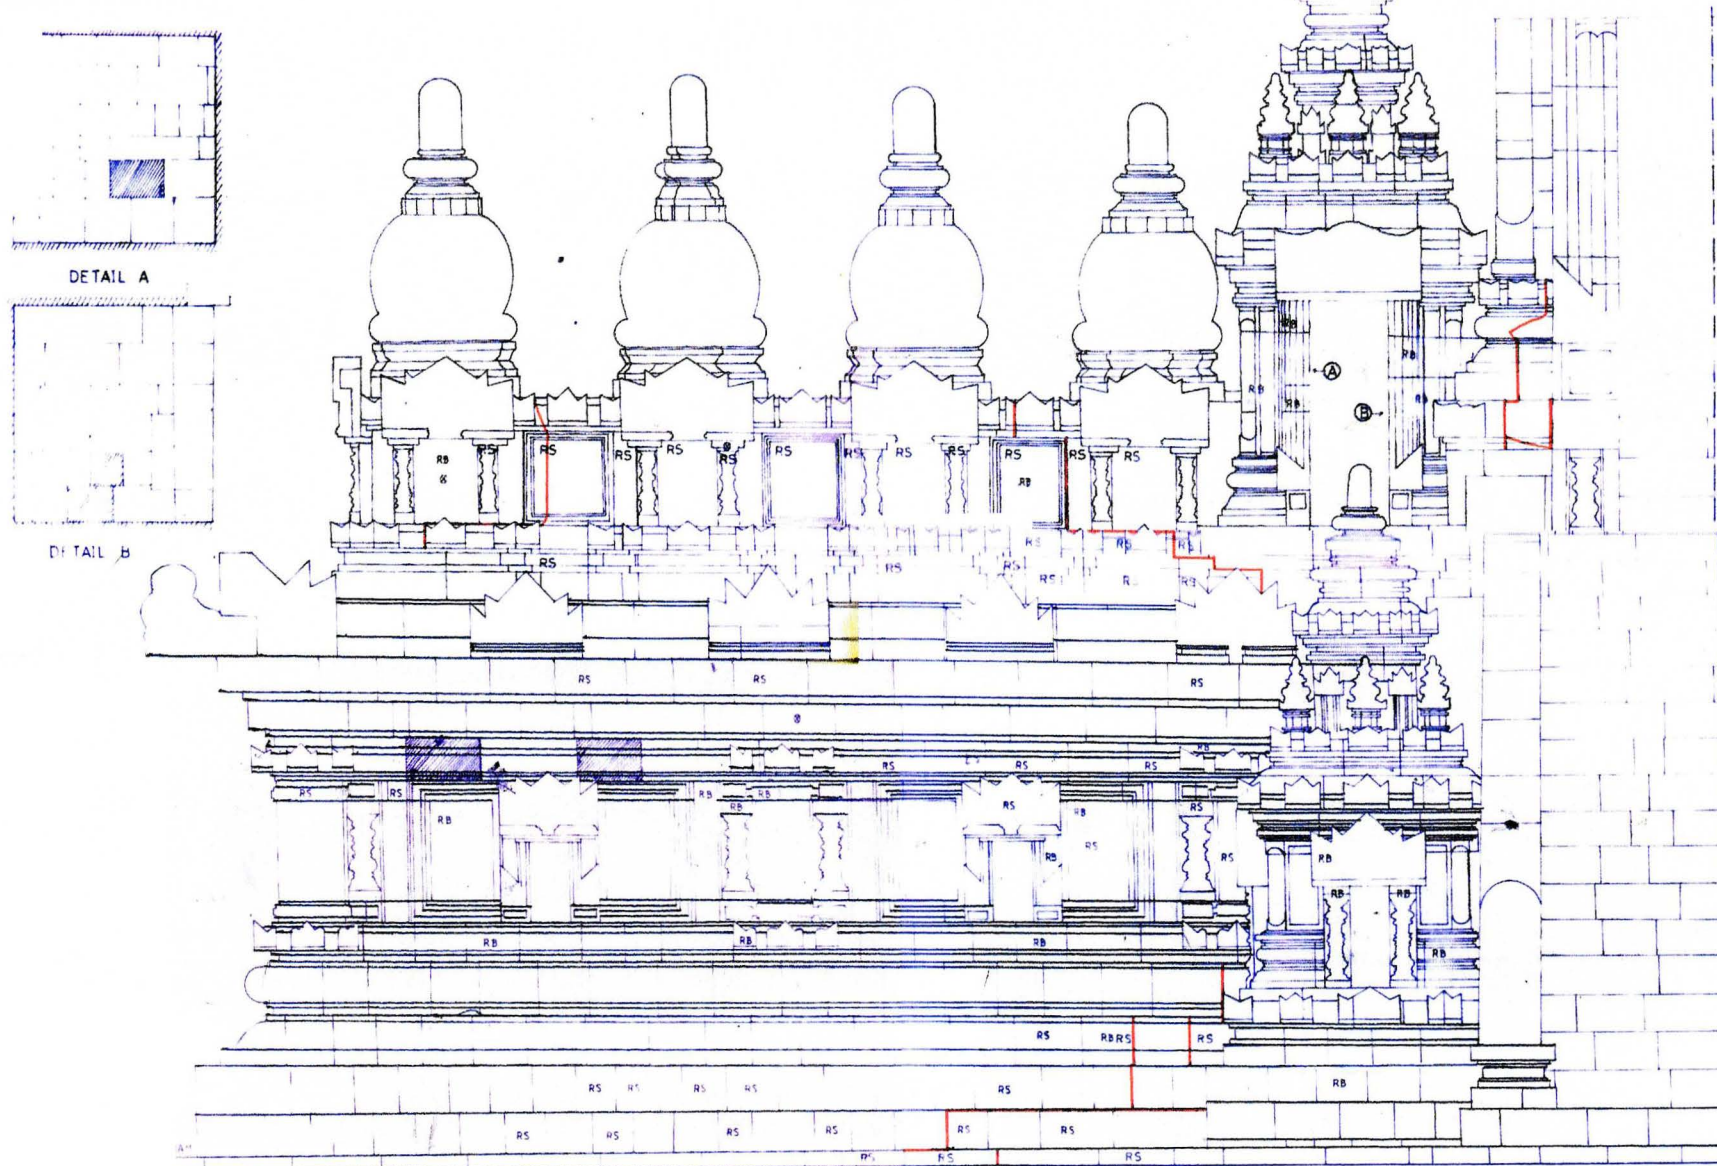
Bidang I  
(Section 1)

CRACKING AND OPEN JOINT STONES ON SIWA TEMPLE

Candi Siwa  
Kaki I dan Pagar Langkan  
(Base Siwa 1 and balustrade )

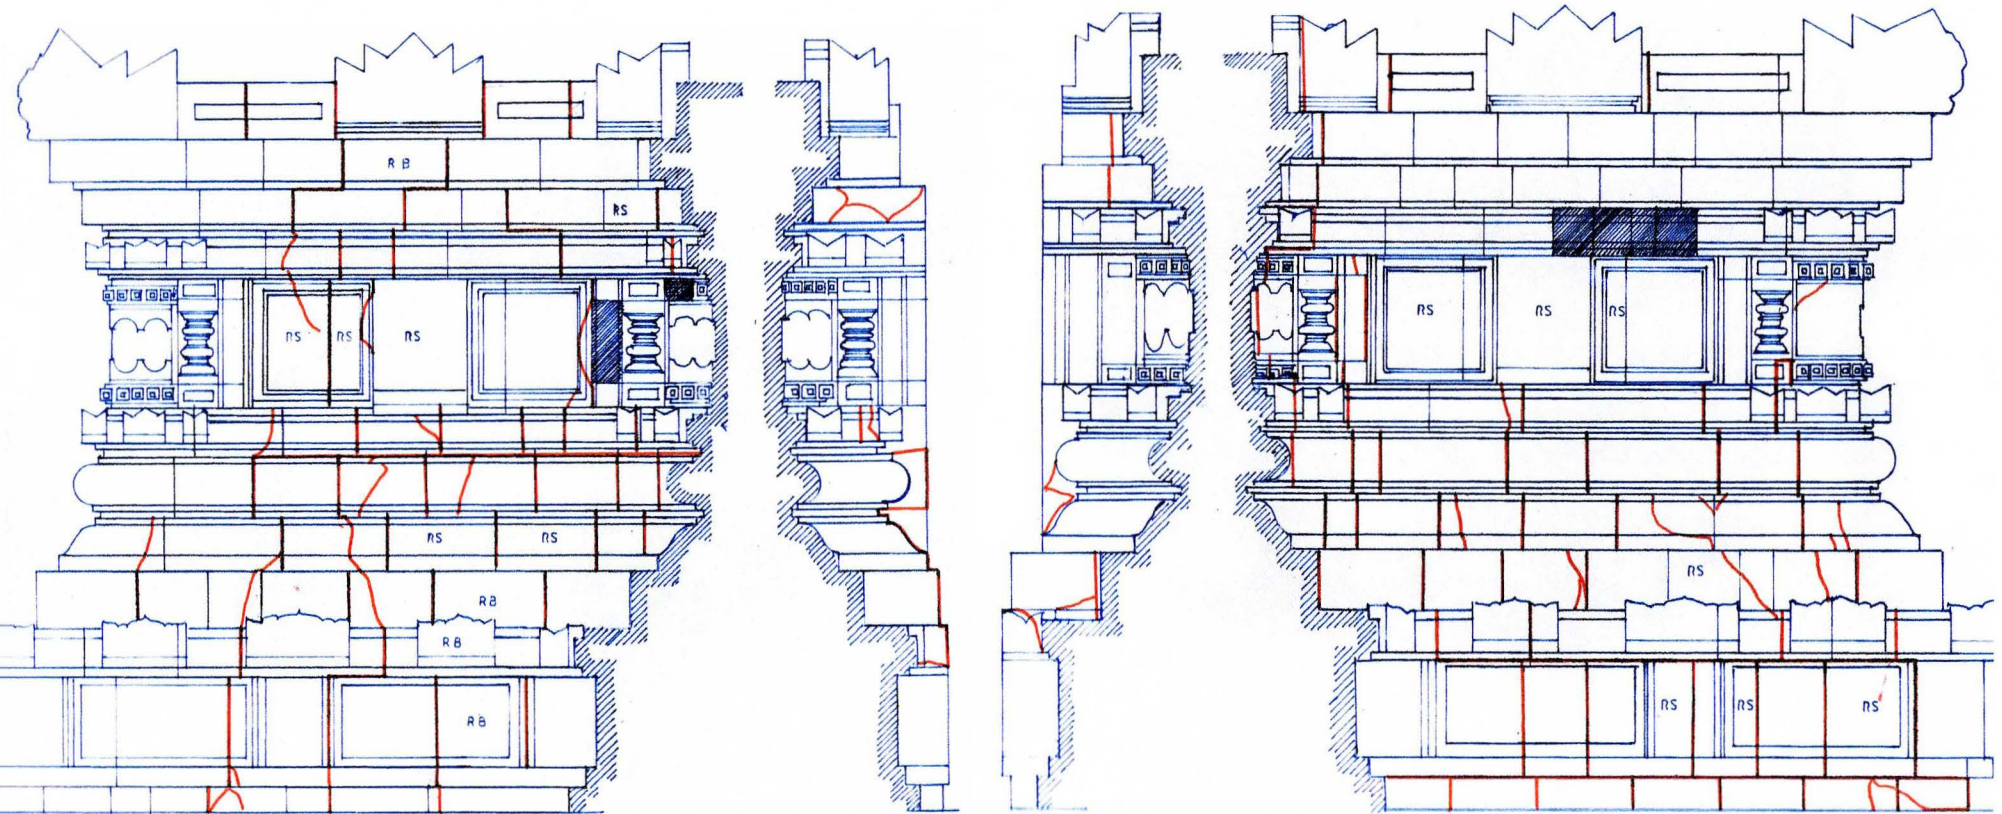
Area I

— Craking and open joint stone

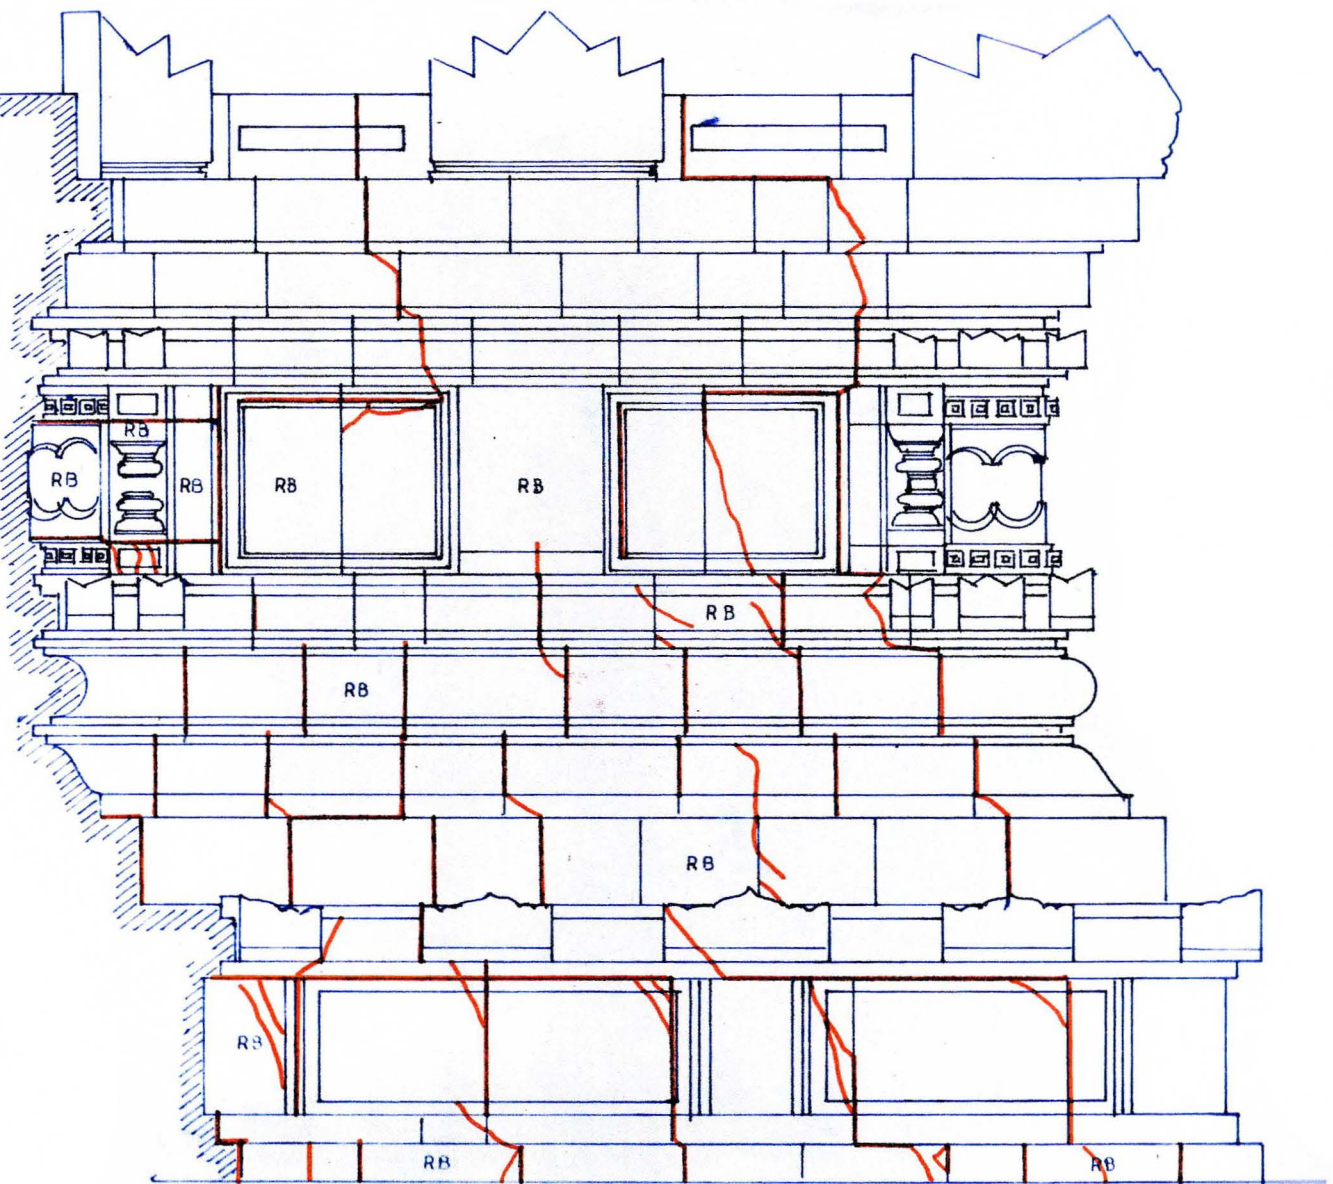
Area II

— Cracking and open joint stone

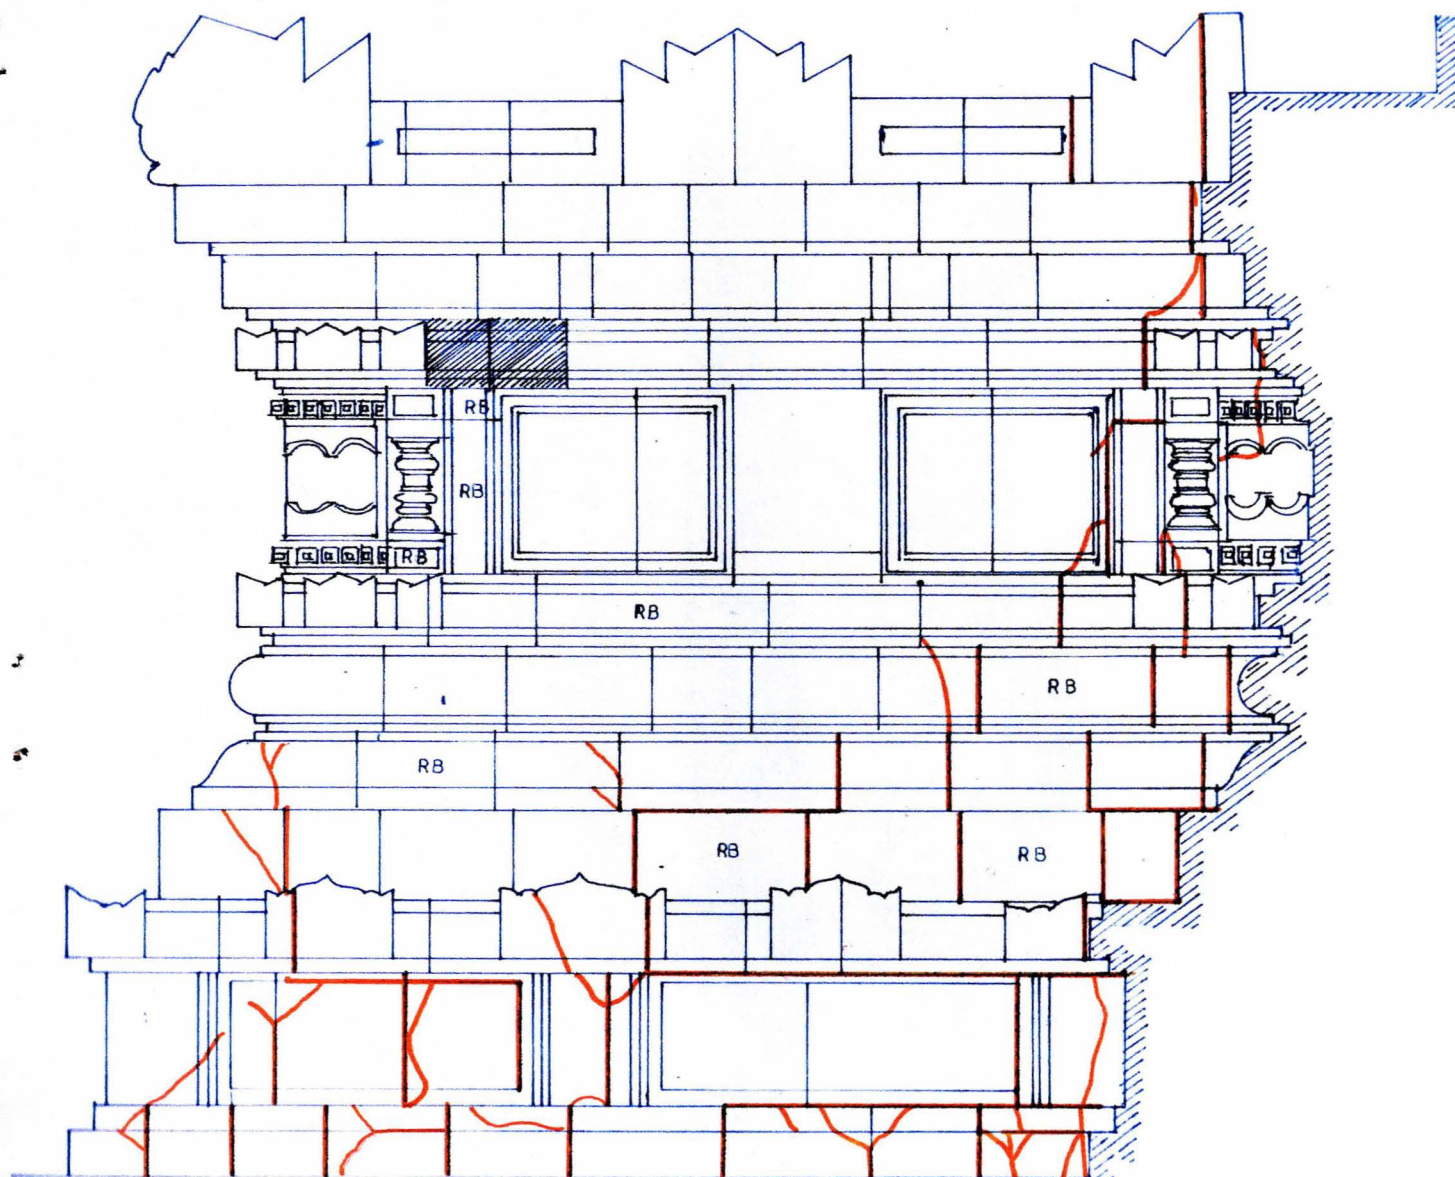
Area 3

— Cracking and open joint stone

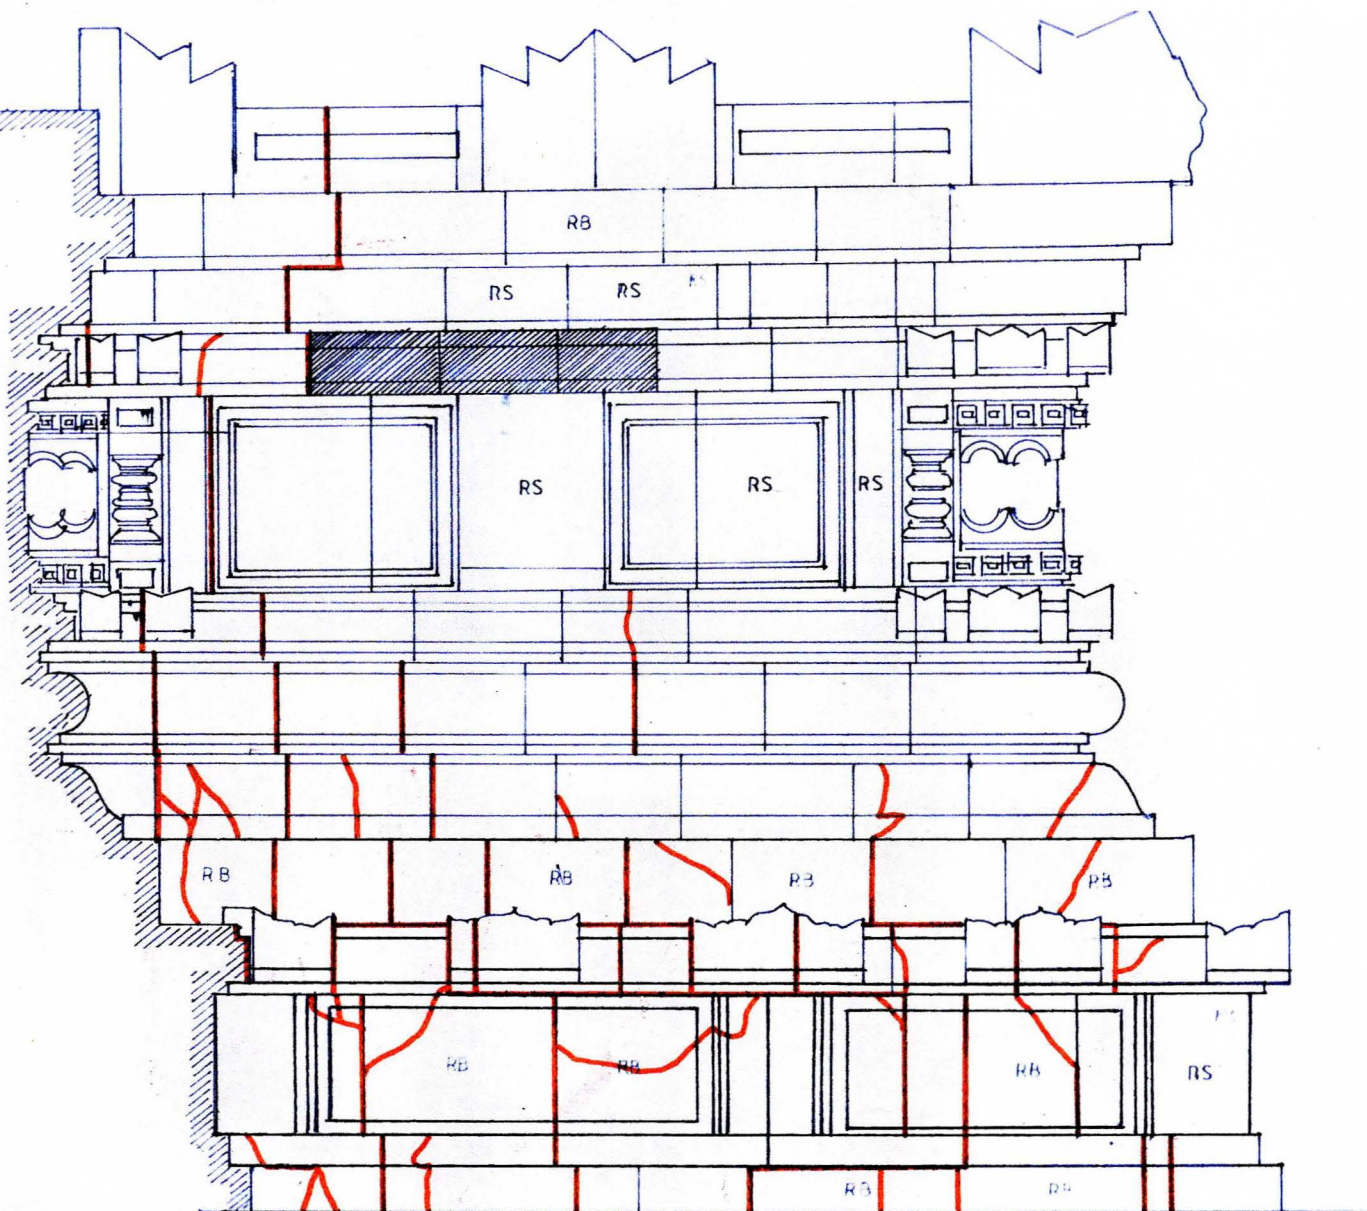
Area 4

— Cracking and open joint stone

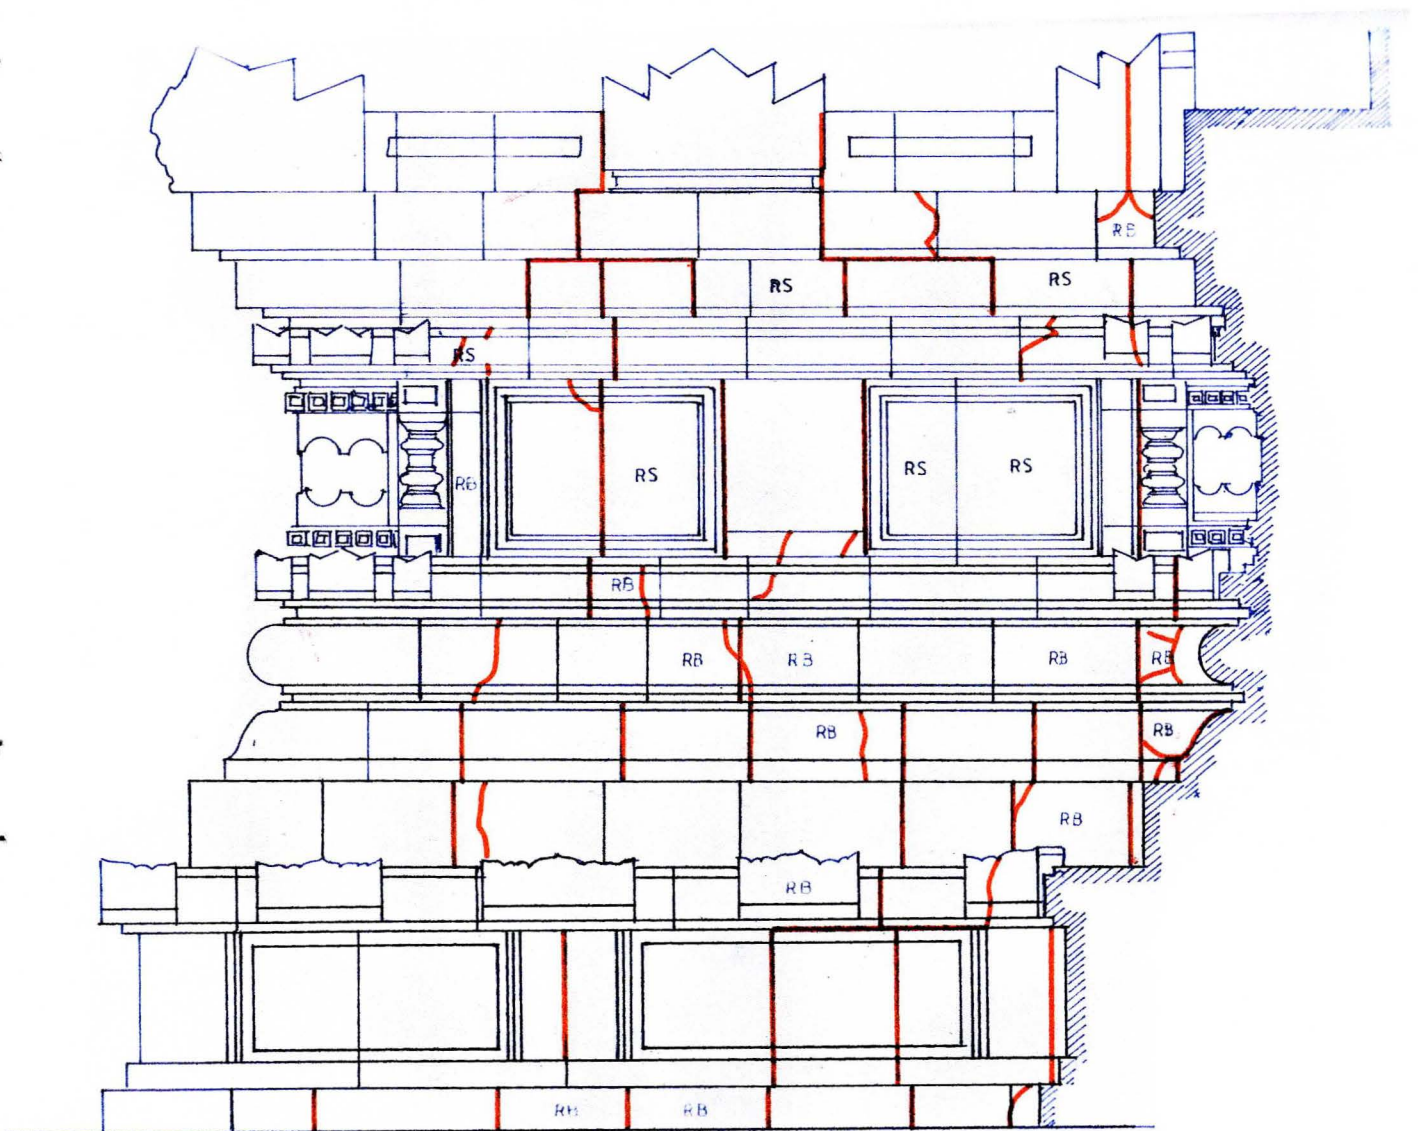
## Area 5

— Cracking and open joint stone

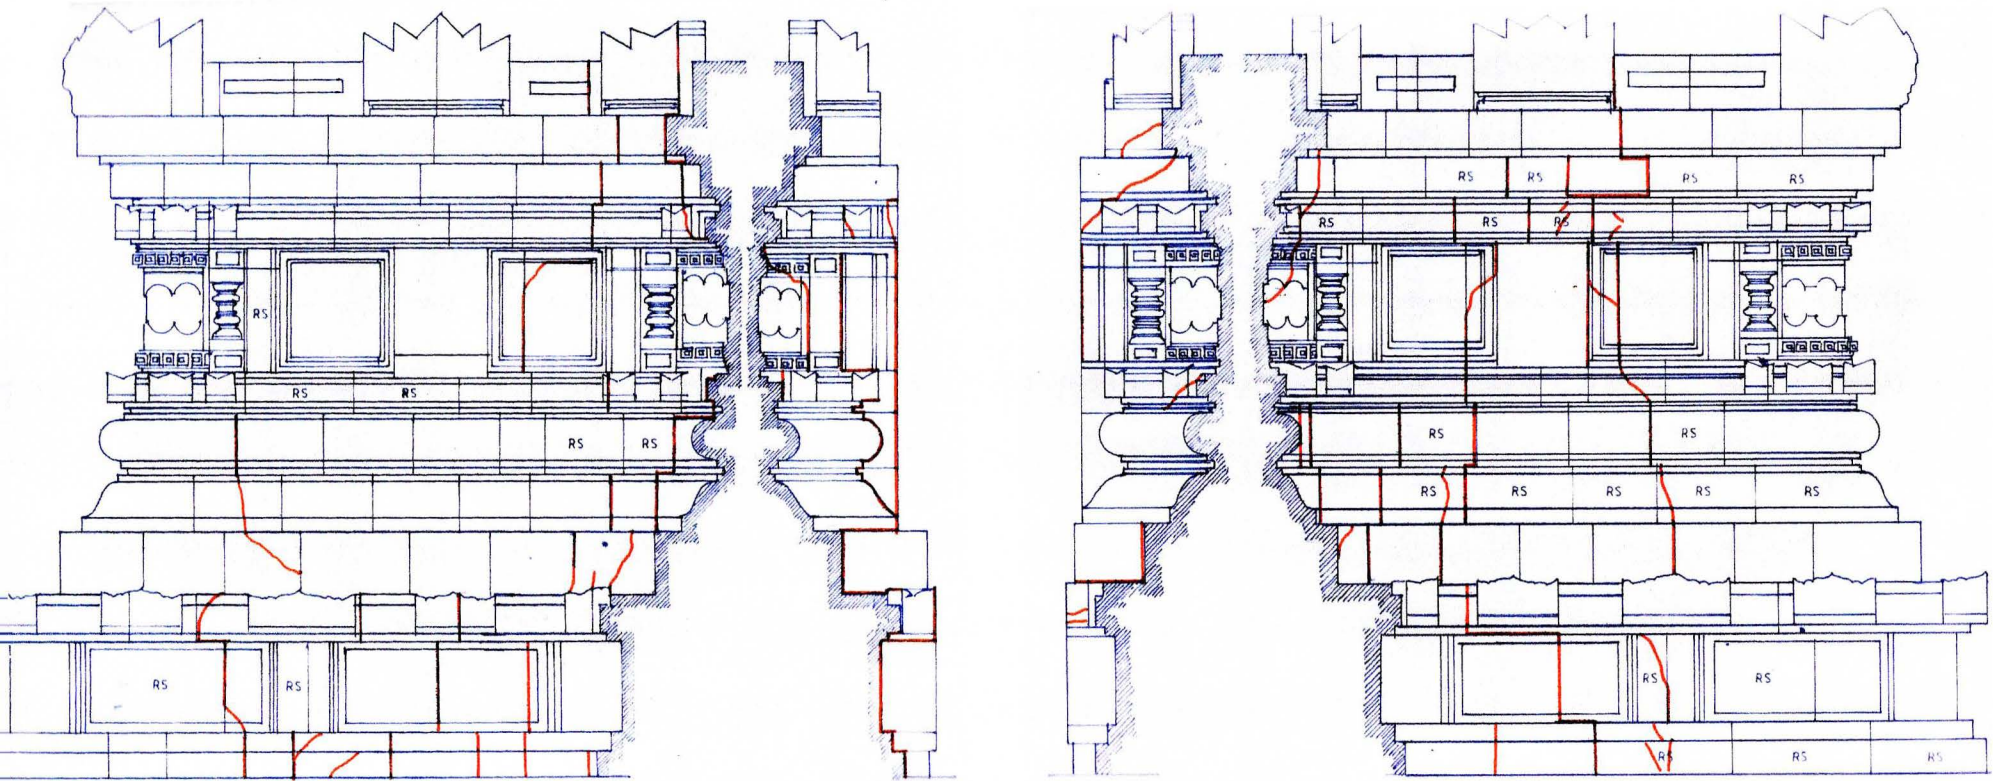
Area 6

— Cracking and open joint stone

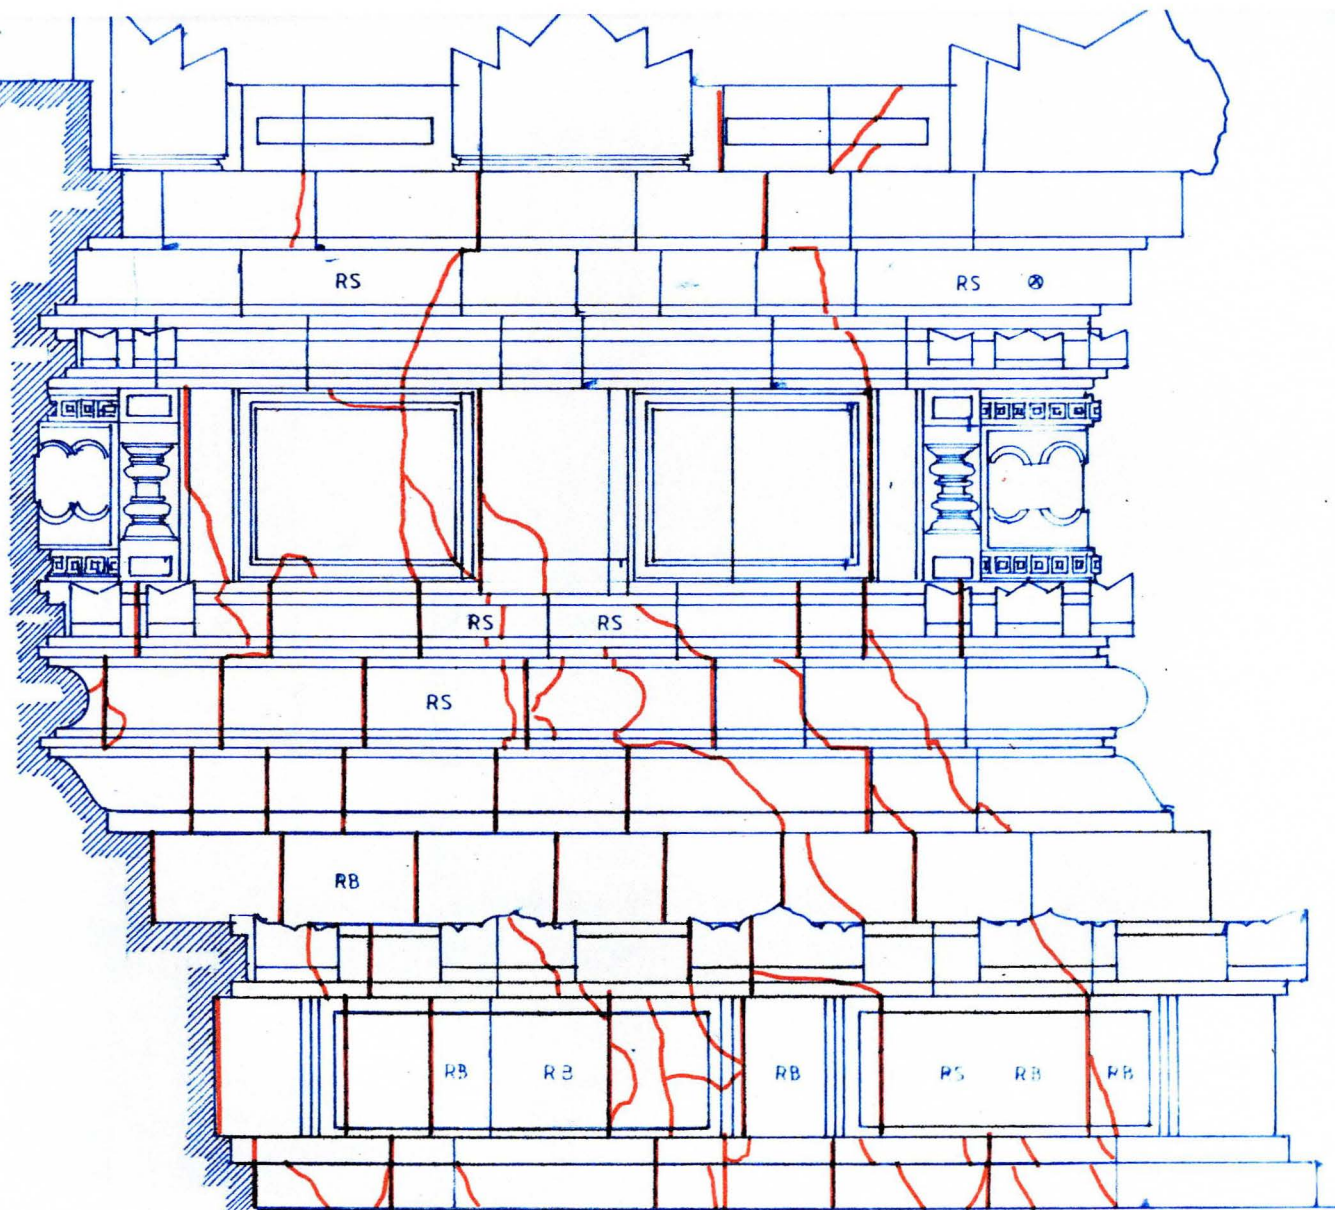
## Area 7

— Cracking and open joint stone

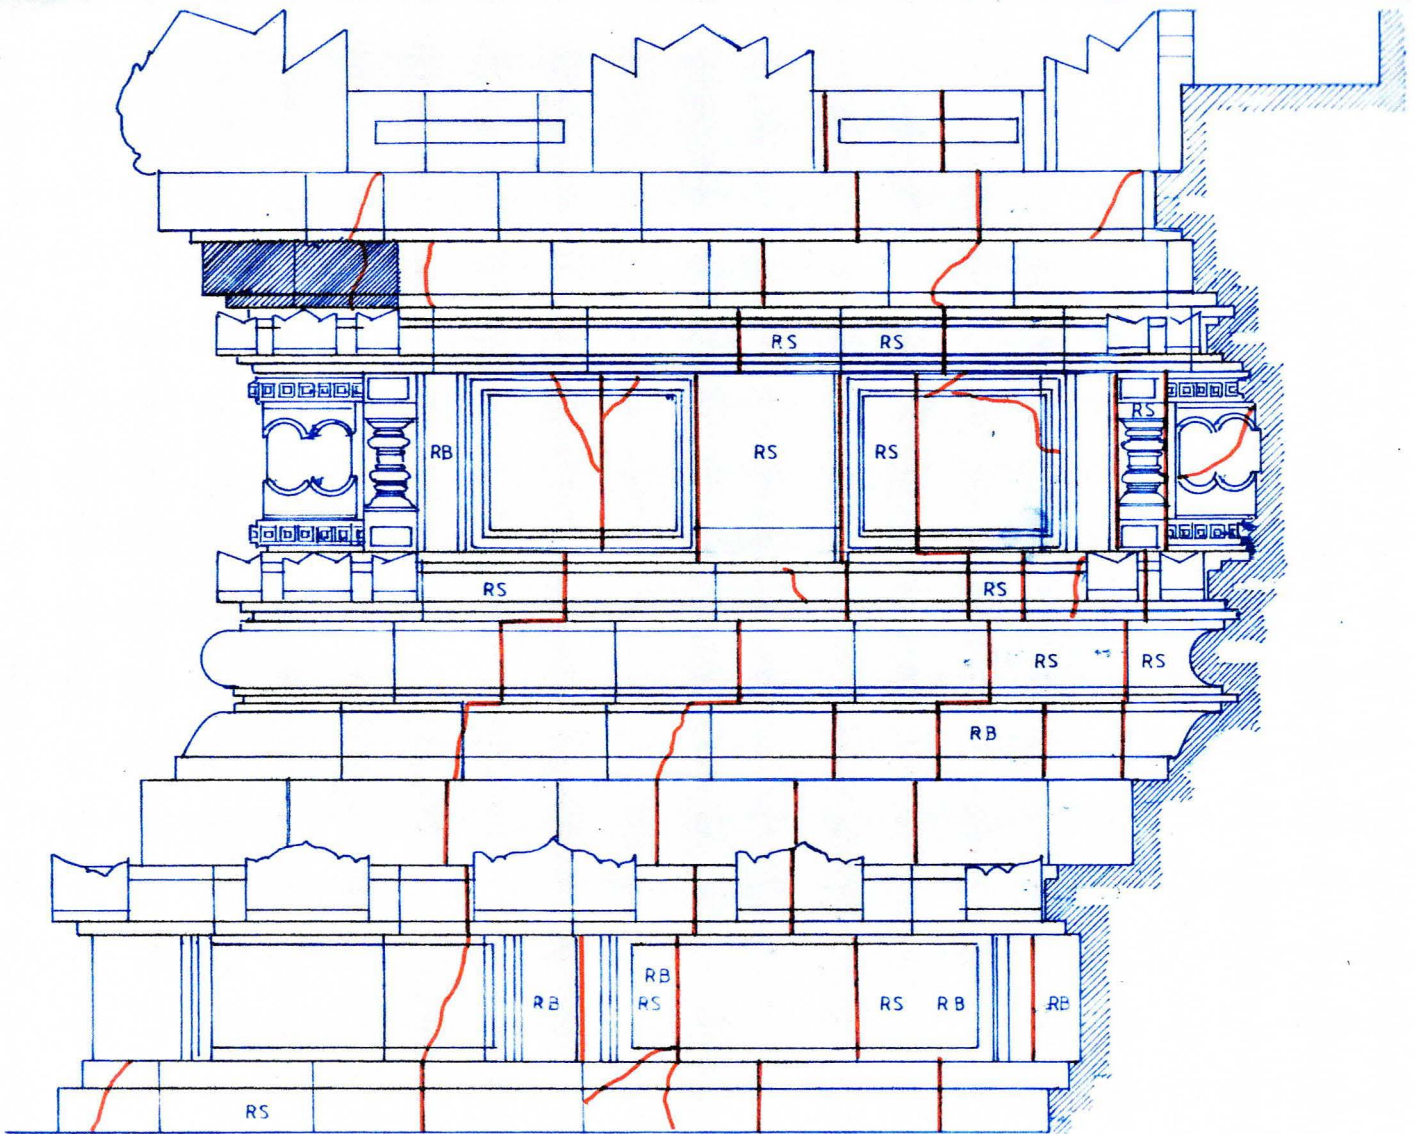
## Area 8

— Craking and open joint stone

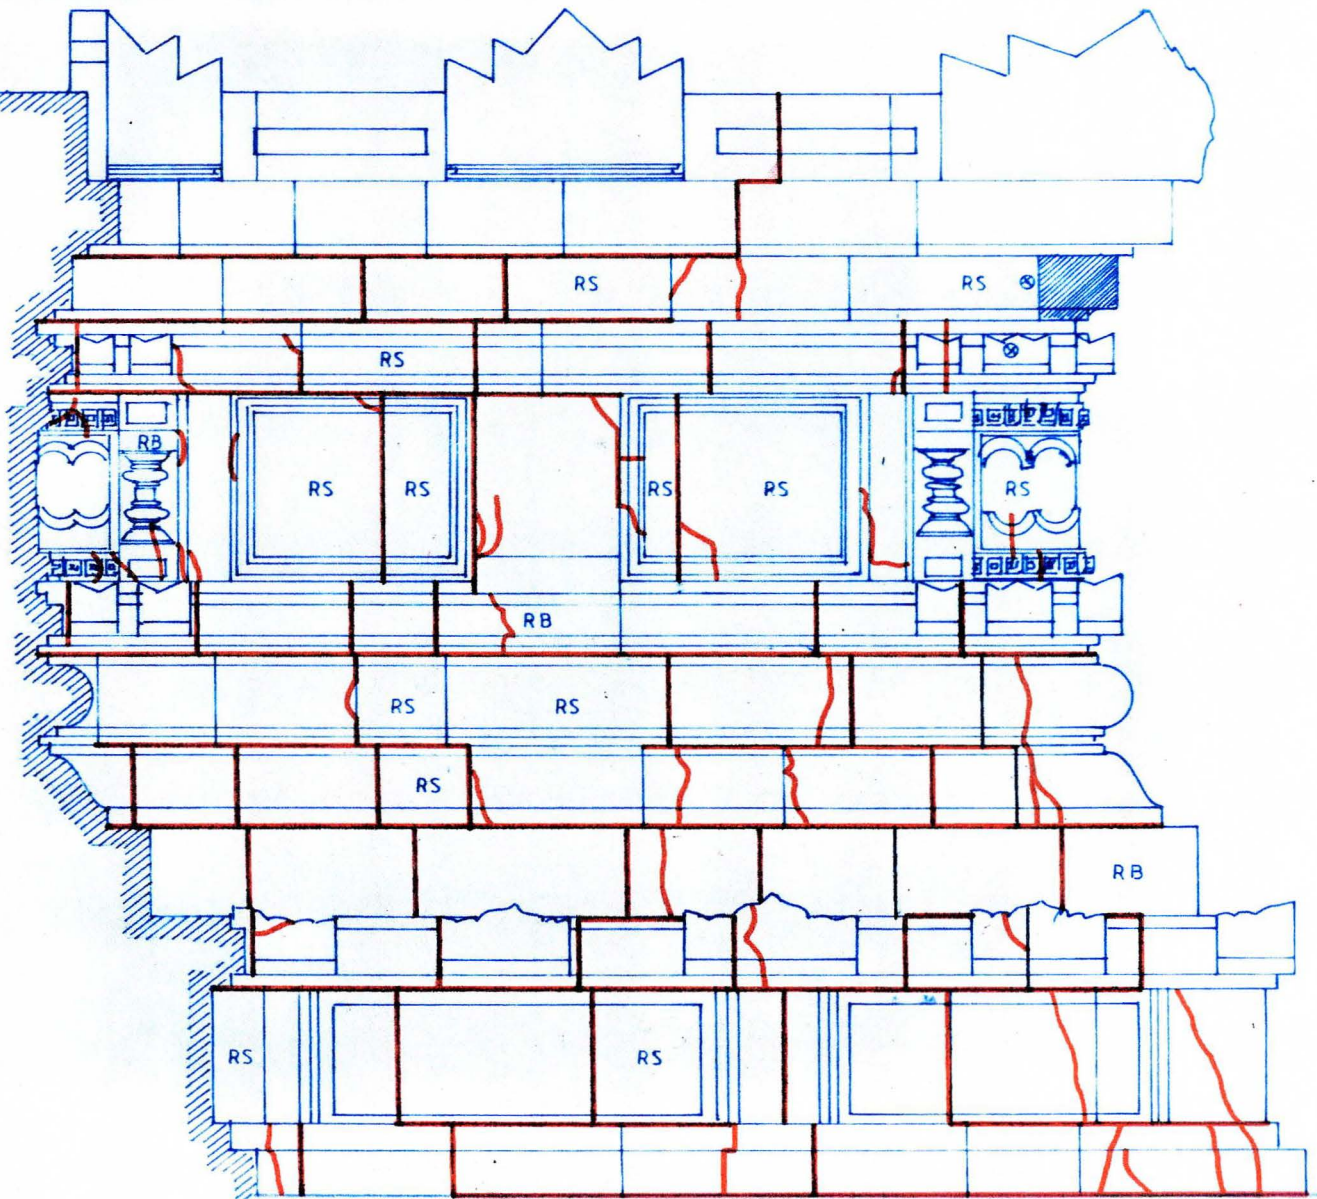
Area 9

— Craking and open joint stone

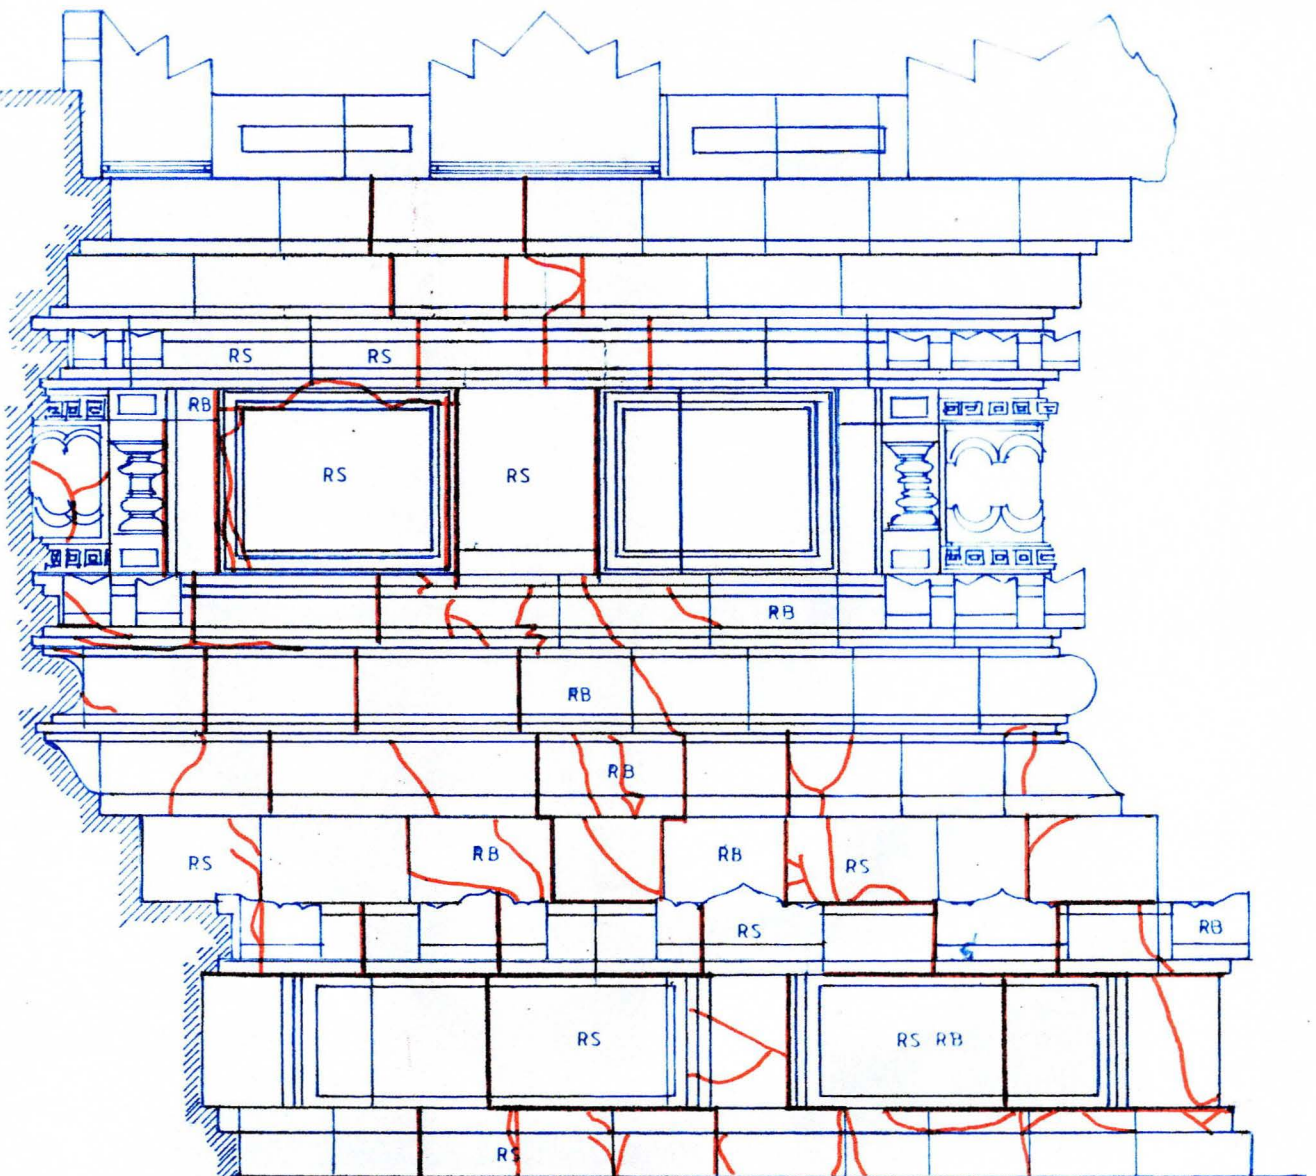
Area 12

— Craking and open joint stone

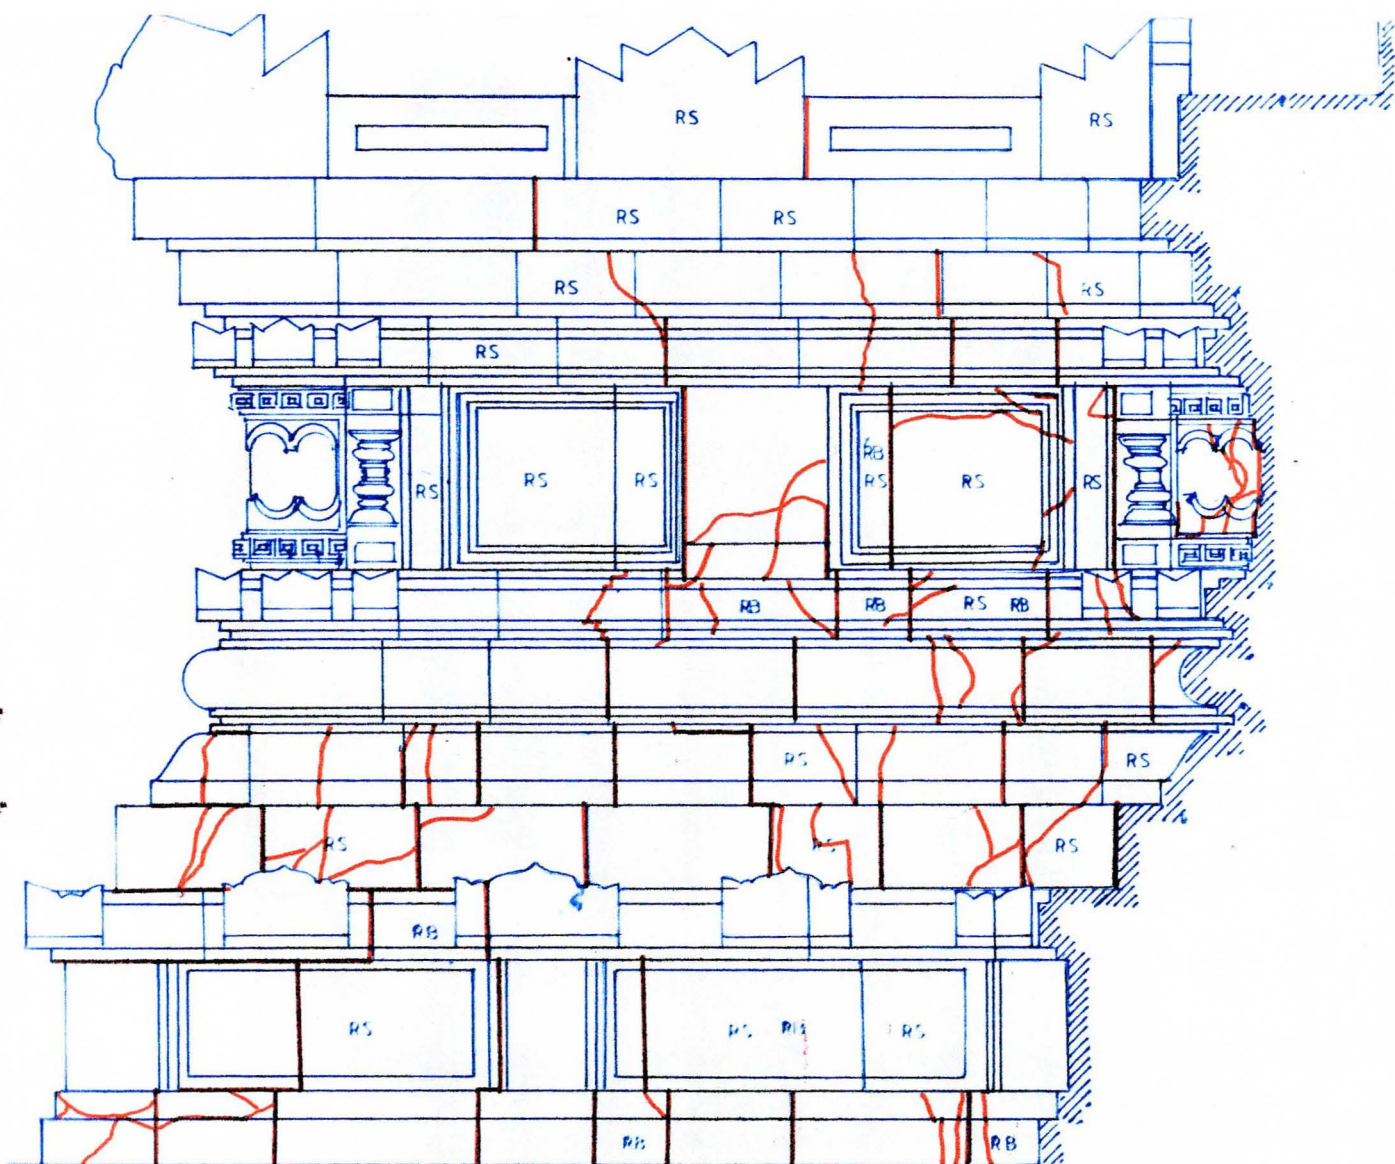
## Area 13

— Craking and open joint stone
