**TECHNICAL STUDY**  
**FOR REHABILITATION**  
**ON PRAMBANAN TEMPLE COMPOUND**  
**AFTER EARTHQUAKE**

BY  
**TECHNICAL STUDY TEAM**  
**ARCHAEOLOGICAL OFFICE OF YOGYAKARTA**

**DEPARTMENT OF CULTURE AND TOURISM**  
**2007**

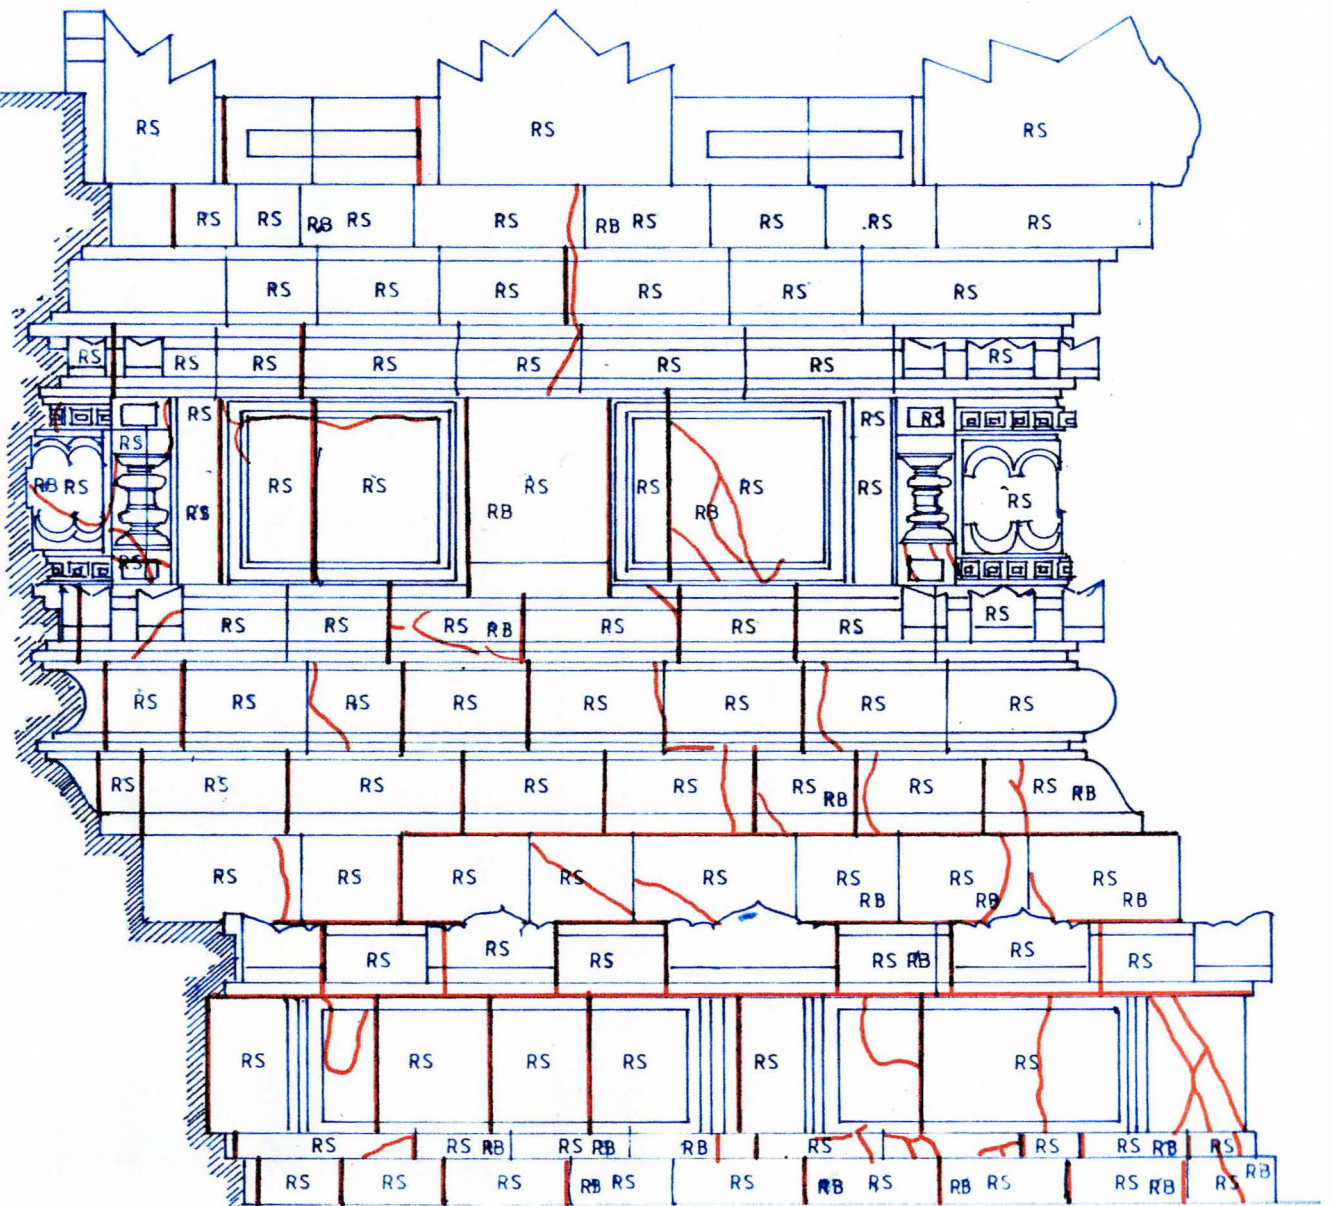
## Area 14

— Cracking and open joint stone

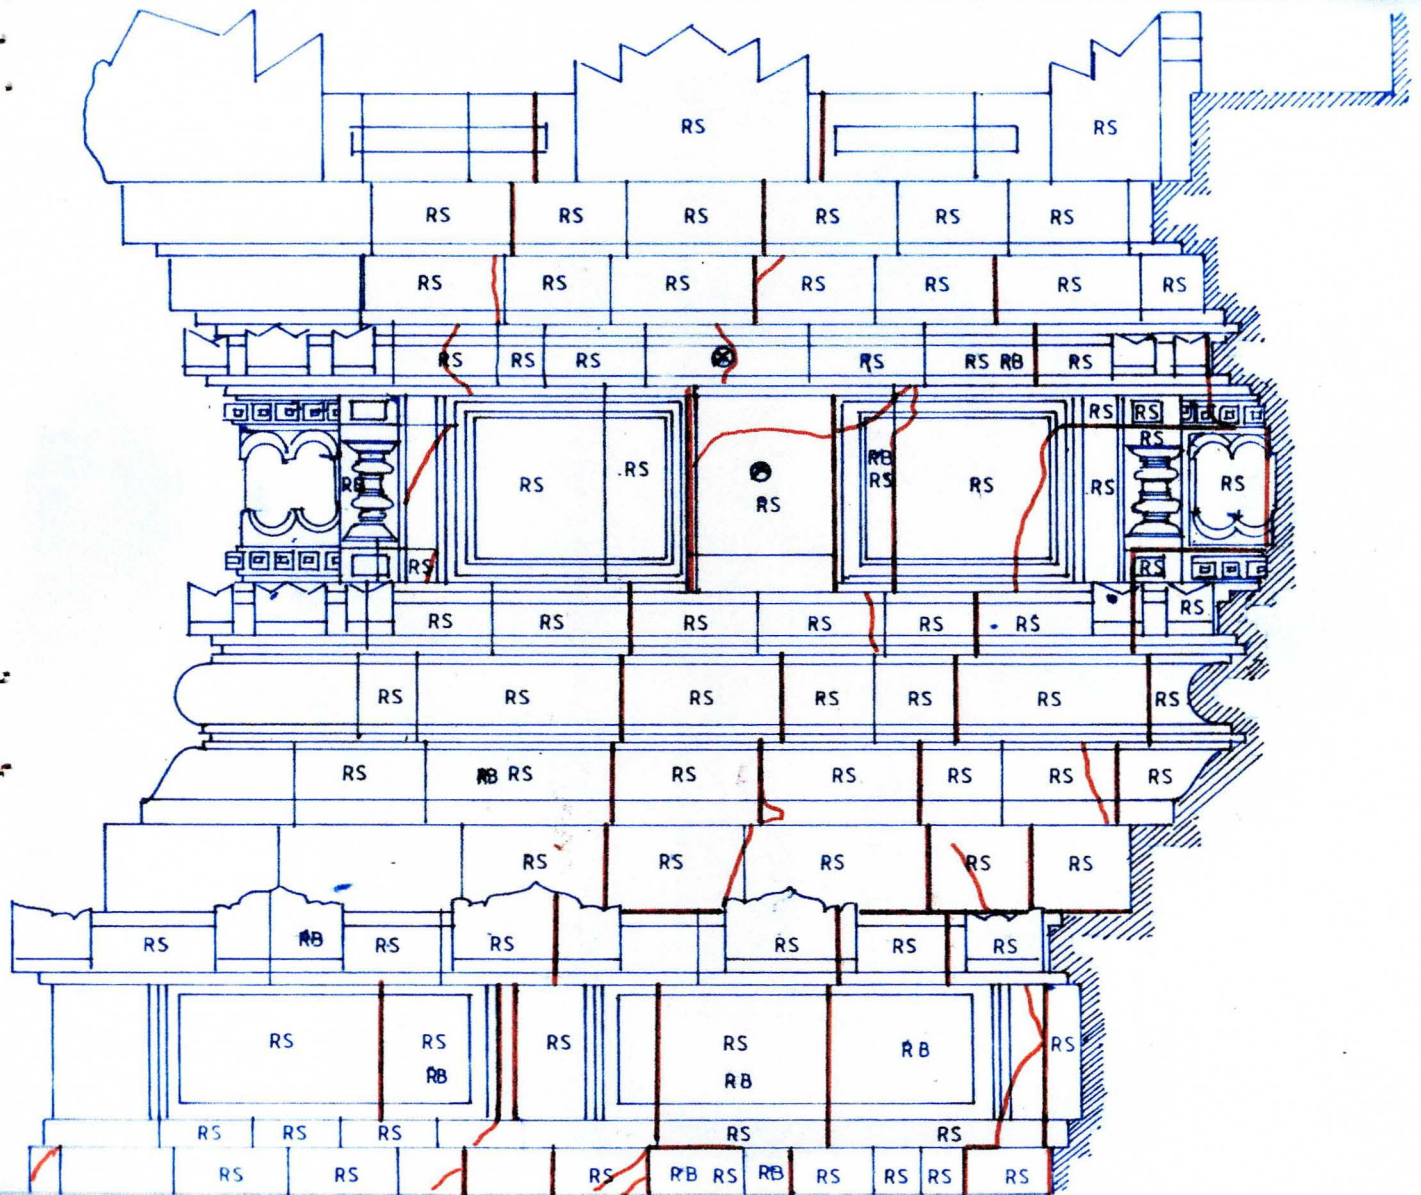
## Area 15

— Craking and open joint

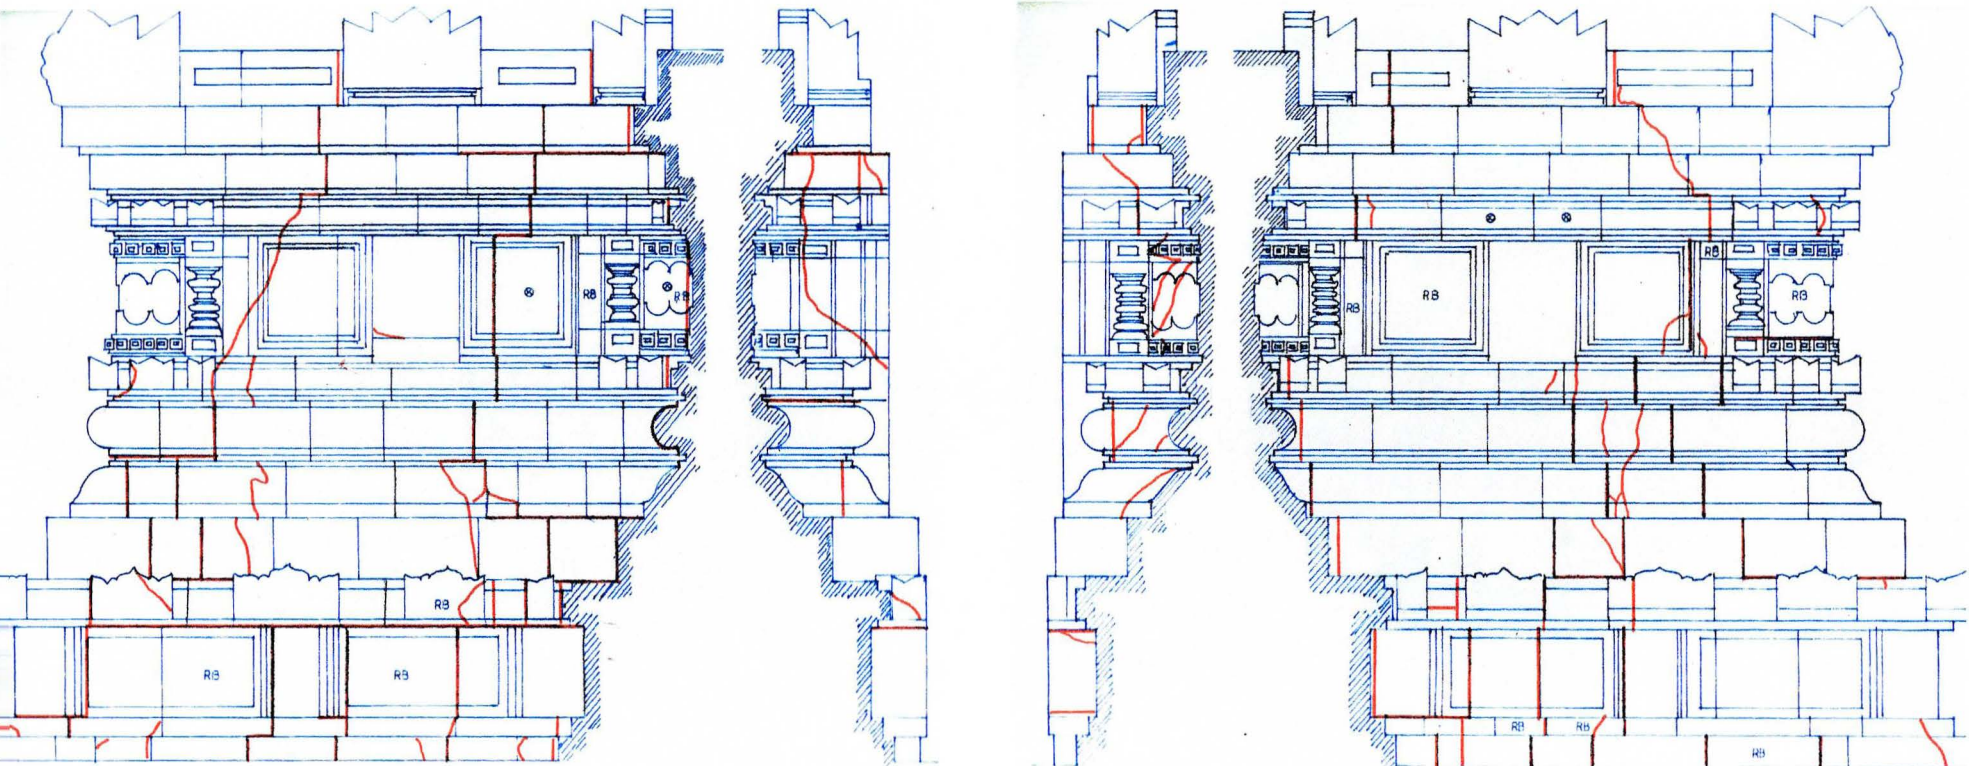
Area XVI

— Cracking and open joint stone

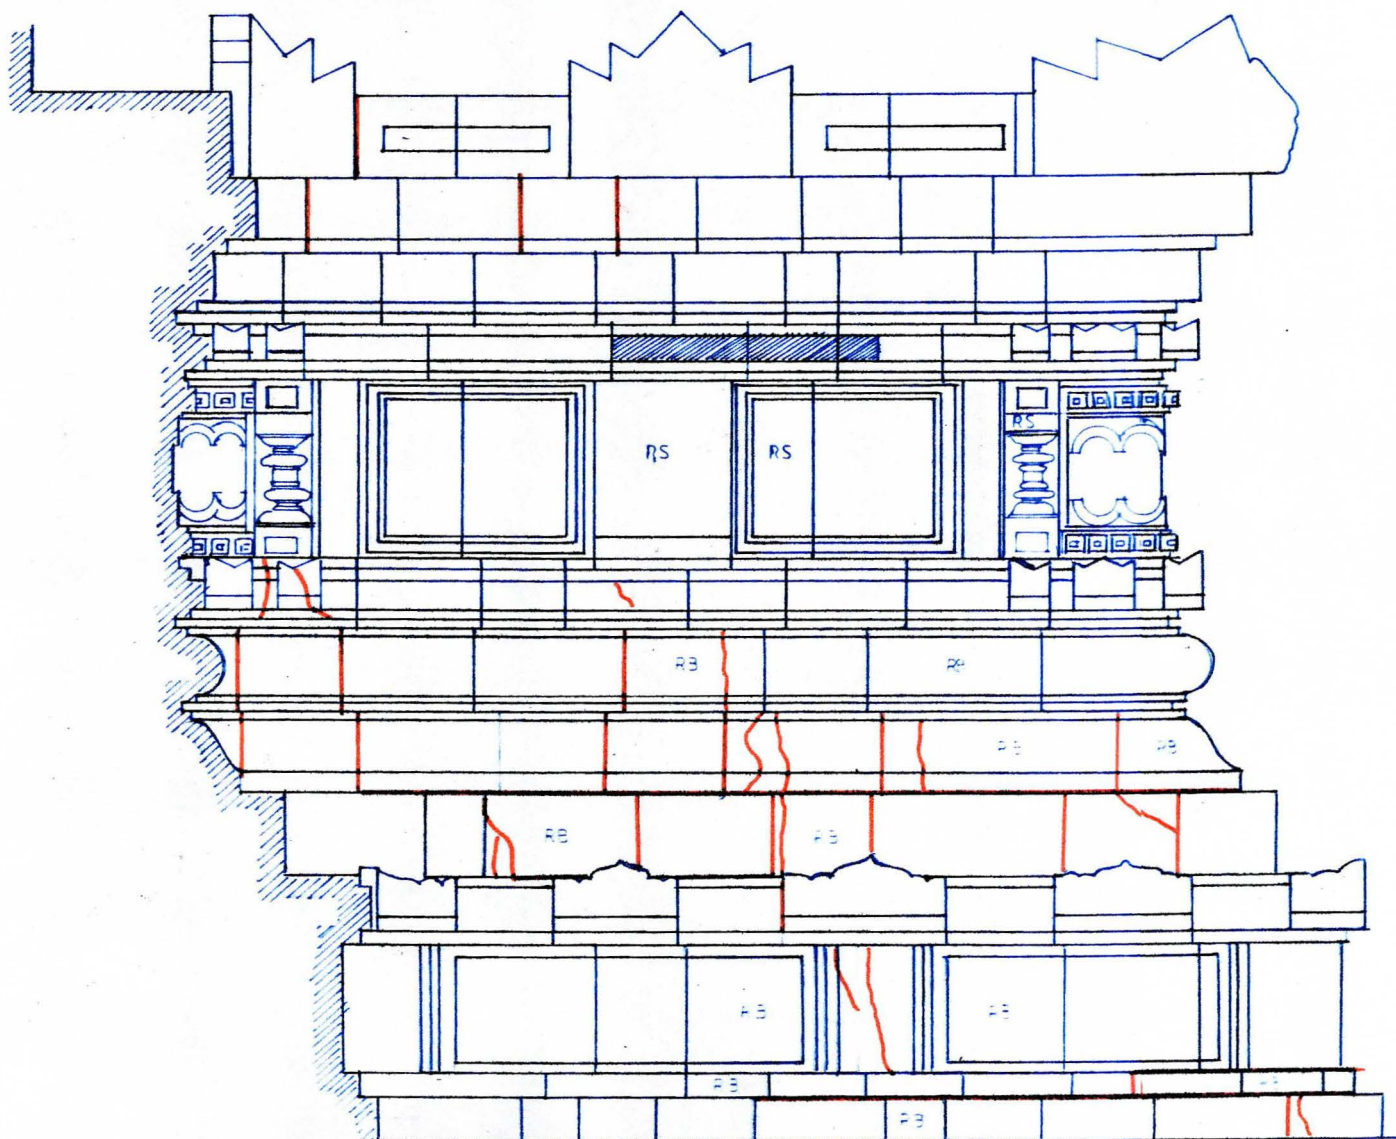
## Area 17

— Craking and open joint stone

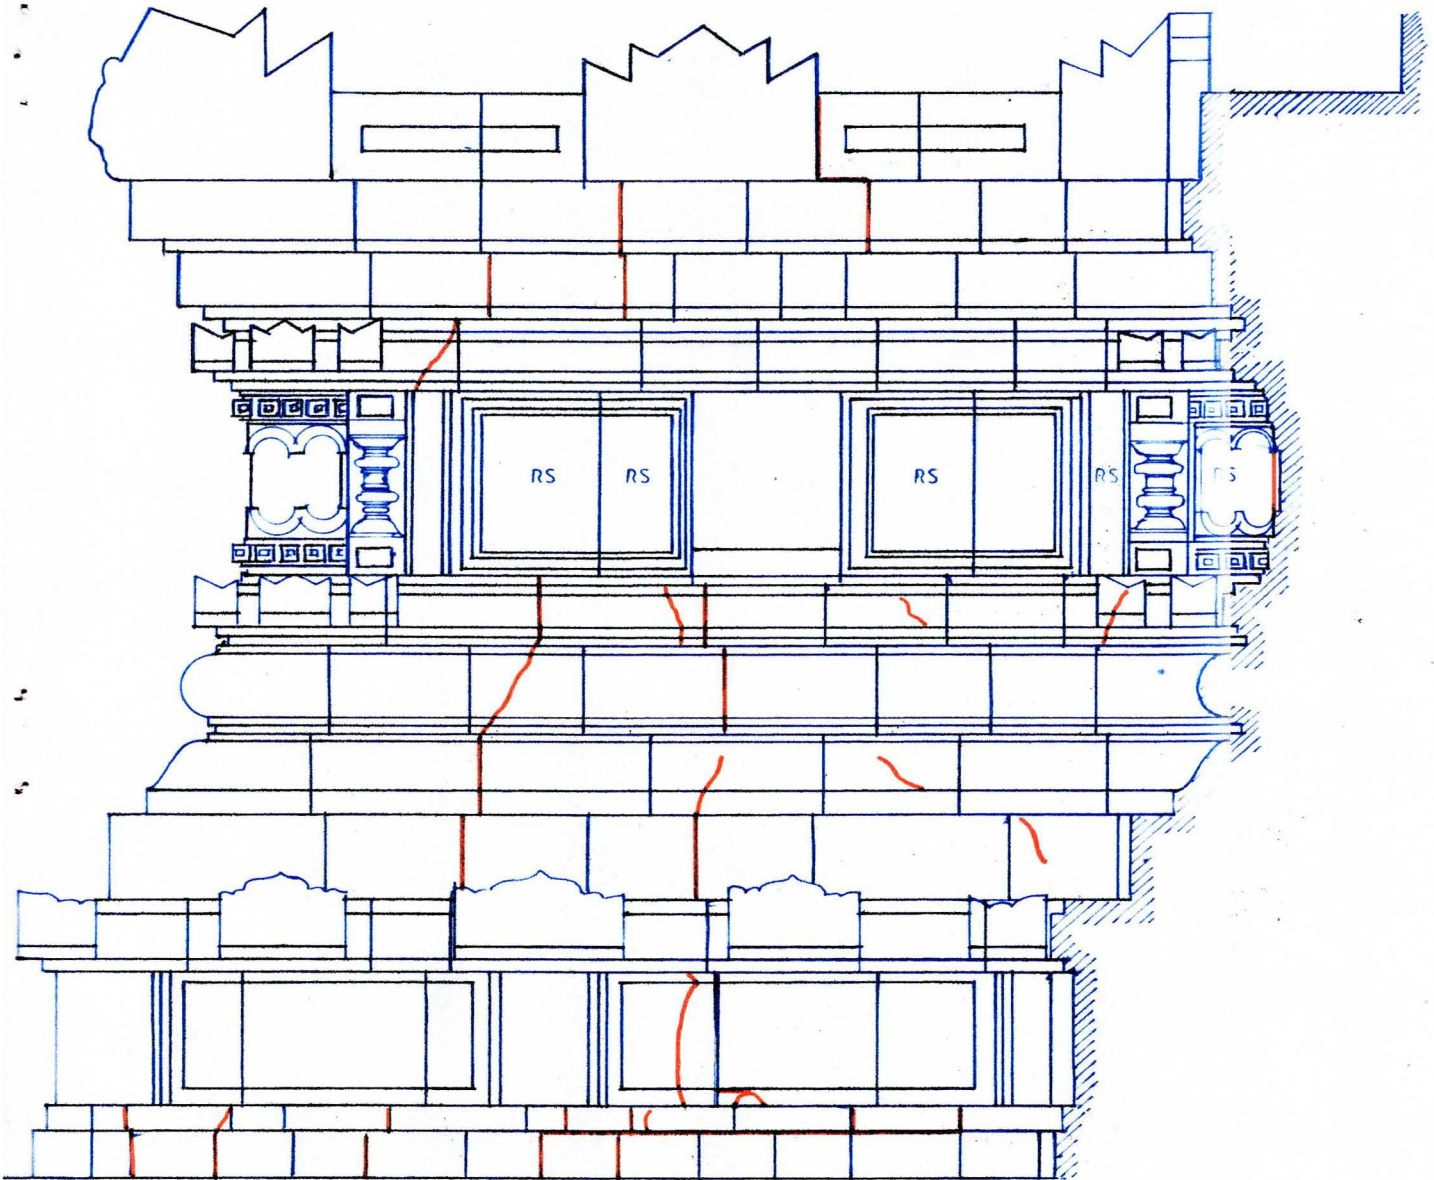
Area18

— Craking and open joint stone

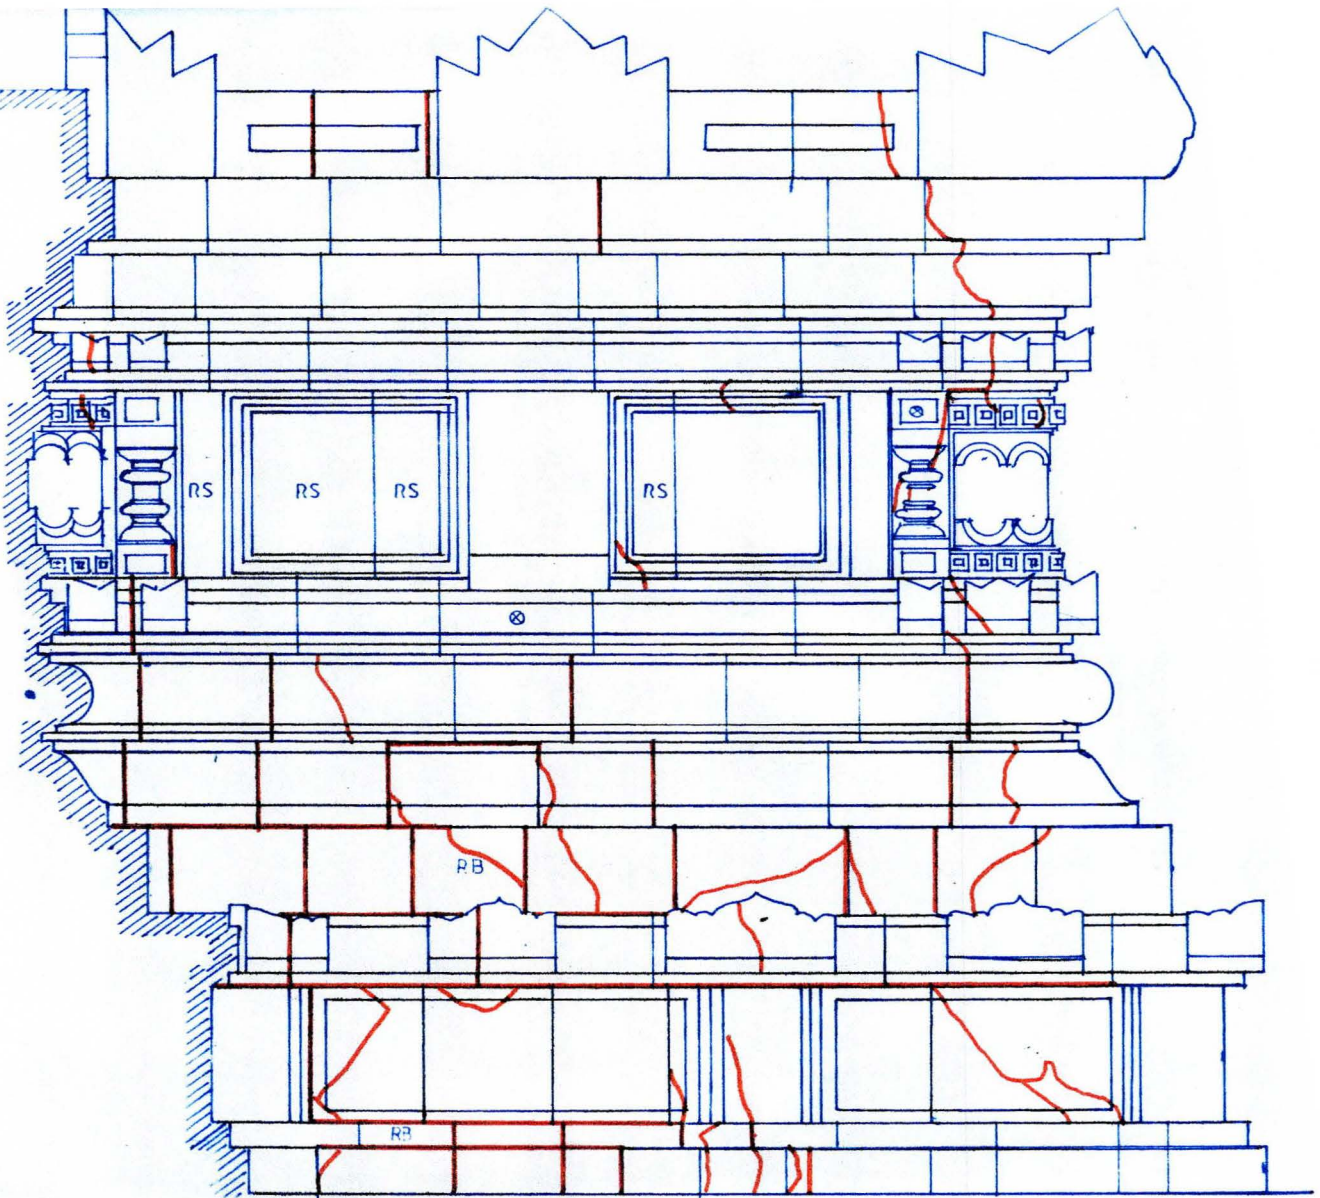
Area 19

Craking and open joint stone

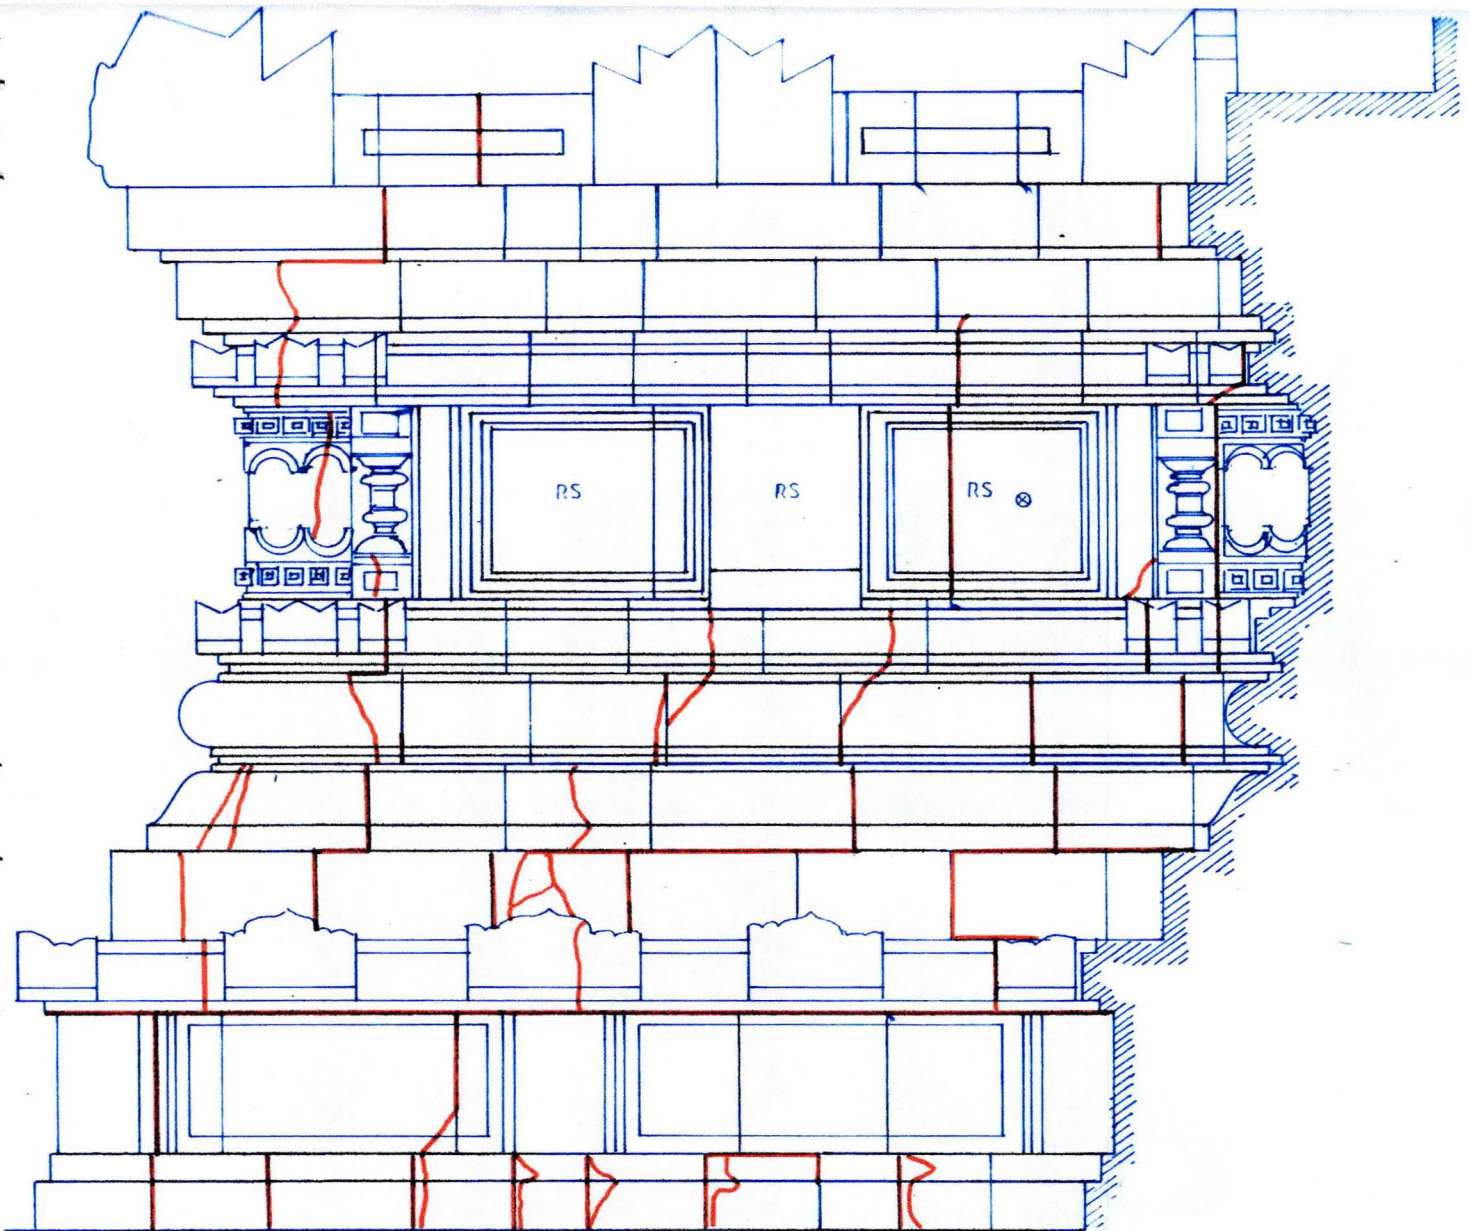
Area 20

— Craking and open joint stone

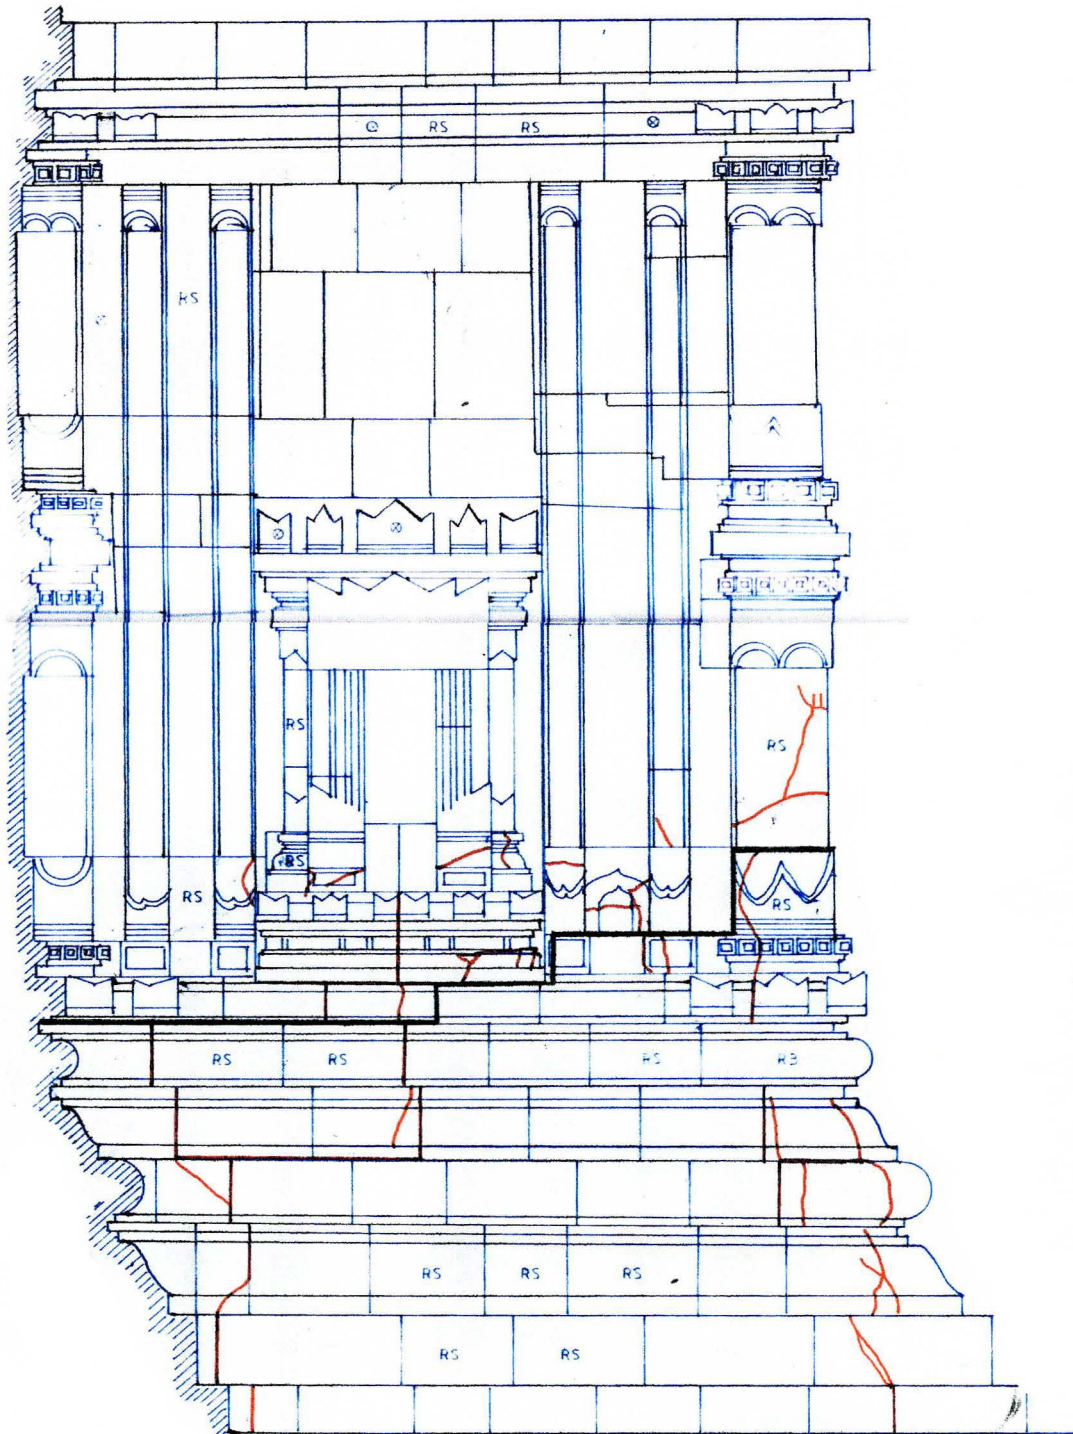
Area 9

— Craking and open joint stone

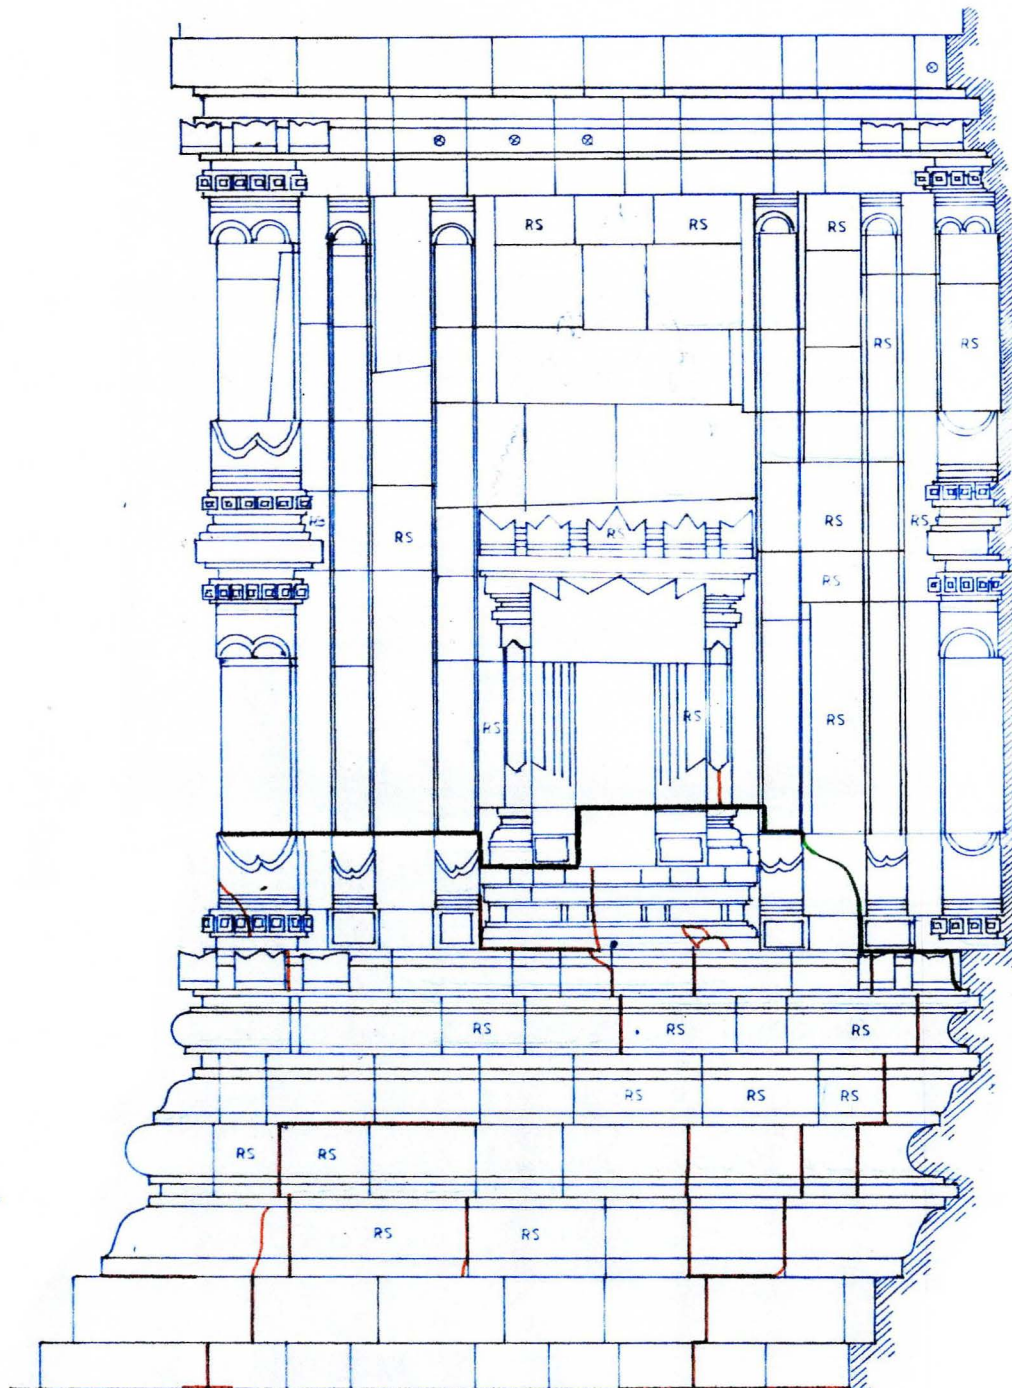
Area X

Cracking and open joint stone

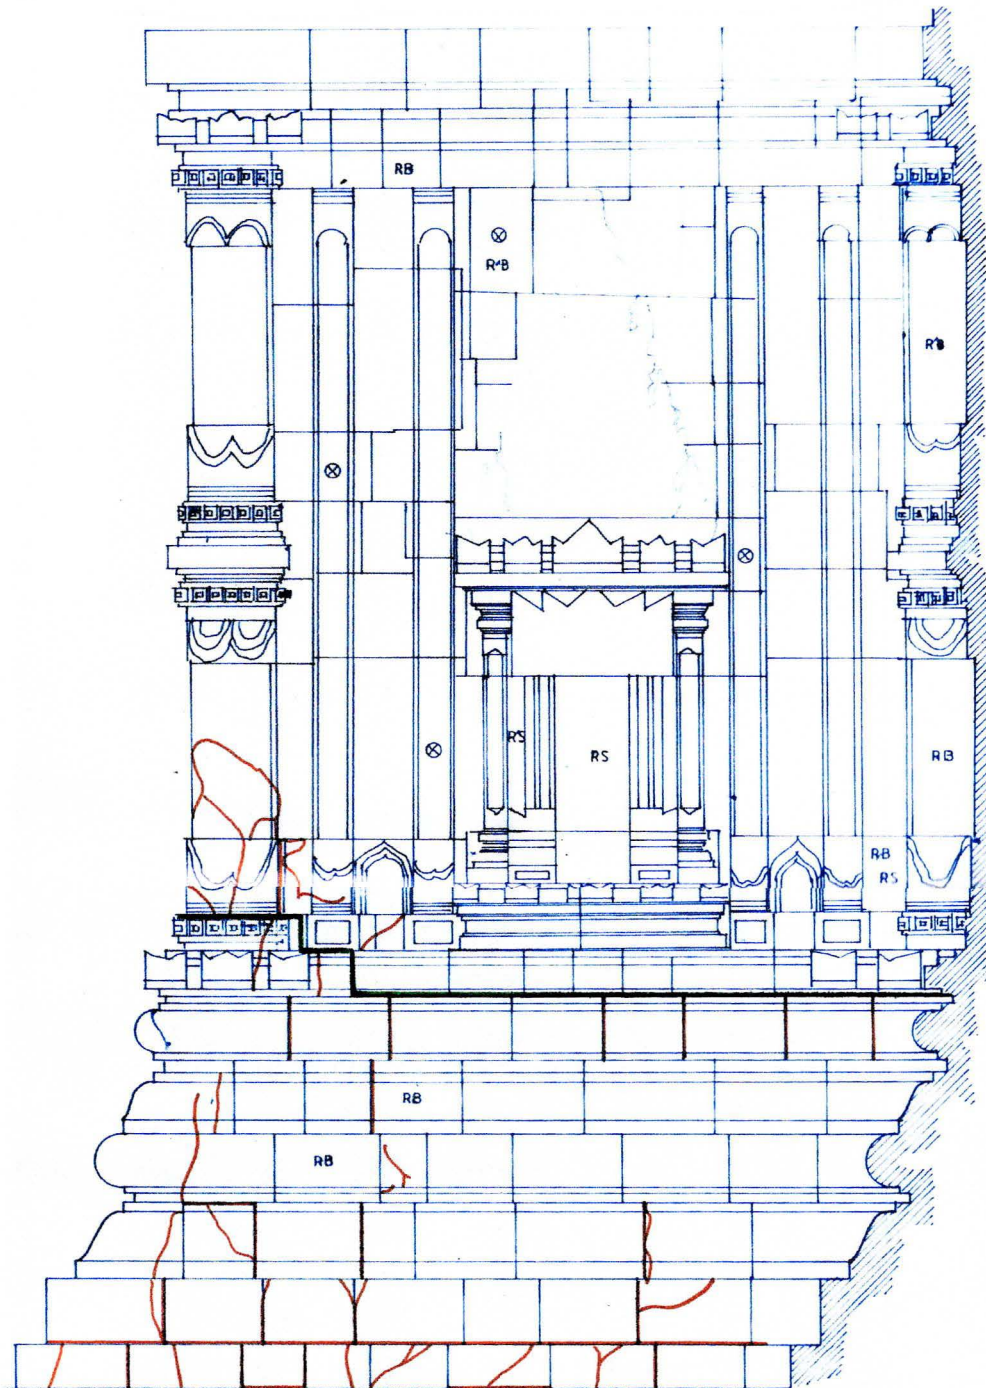
Area XV

Craking and open joint stone
