**TECHNICAL STUDY**  
**FOR REHABILITATION**  
**ON PRAMBANAN TEMPLE COMPOUND**  
**AFTER EARTHQUAKE**

BY  
**TECHNICAL STUDY TEAM**  
**ARCHAEOLOGICAL OFFICE OF YOGYAKARTA**

**DEPARTMENT OF CULTURE AND TOURISM**  
**2007**

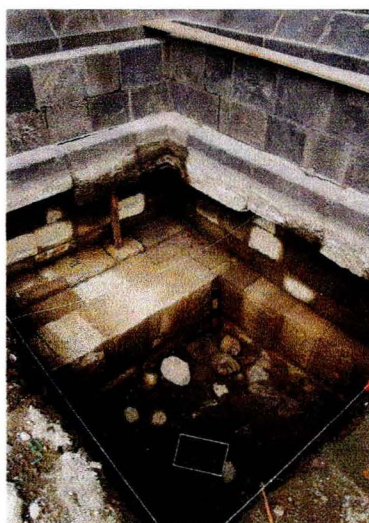
Excavation on Siwa Temple
